SECTION 5 – VULNERABILITY AND ISSUES

5.0 VULNERABILITY AND ISSUES

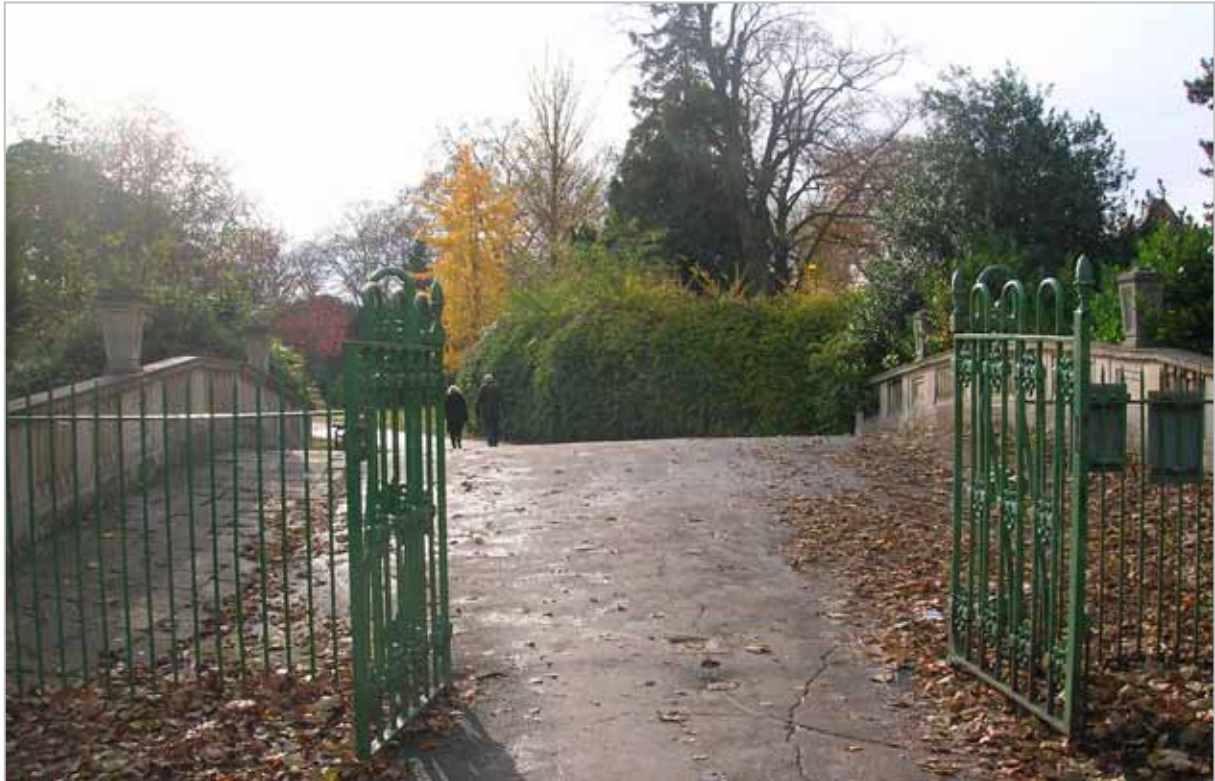
2007 Bridge at the western end of the Upper Lake.

From the south access towards the Pump Room is via an unmarked entrance south of the subway and historic bridge. The hard, bitmac surfaced footpath then leads across the bridge, through green iron railings and gates, towards the pump room.

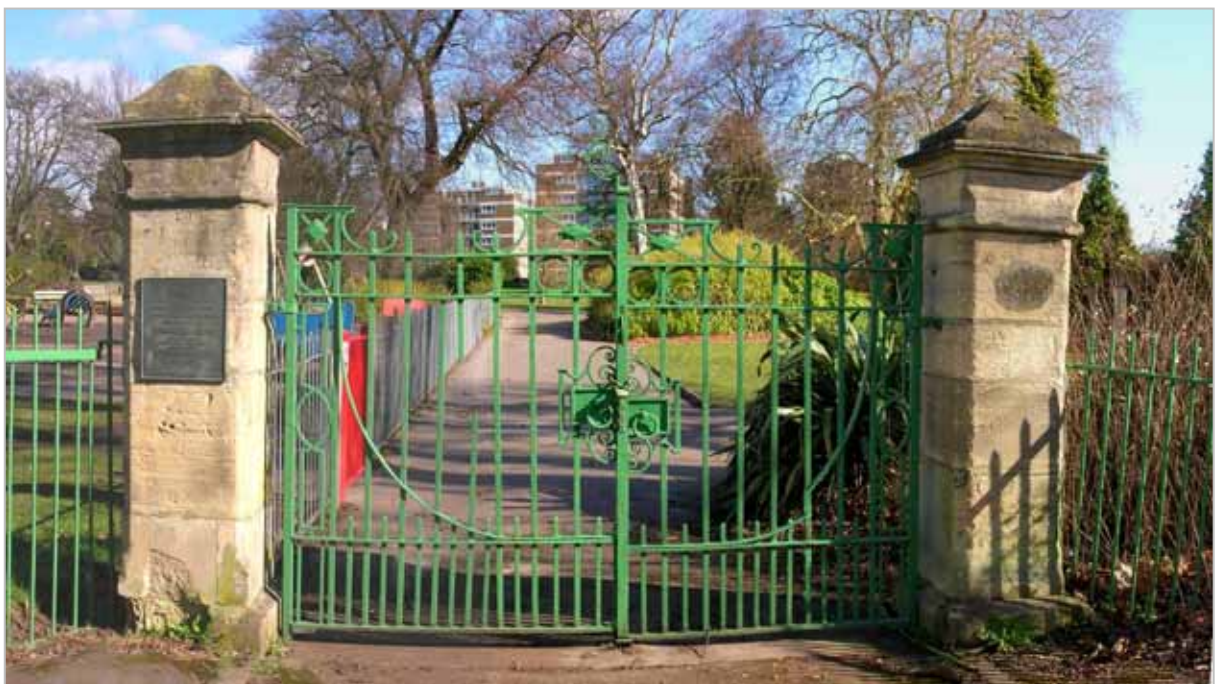
2007 Historic entrance to Pittville Pump Room, off Evesham Road

There is a formal gateway to the north of the bridge, off Evesham Road through high, gothic gate pillars. The iron gates are permanently locked. This formal entrance is in keeping with the character and setting of the park and signifies the historical importance of this entrance. There is no interpretation or signage here other than a dedication to the person for whom the gates were purchased.

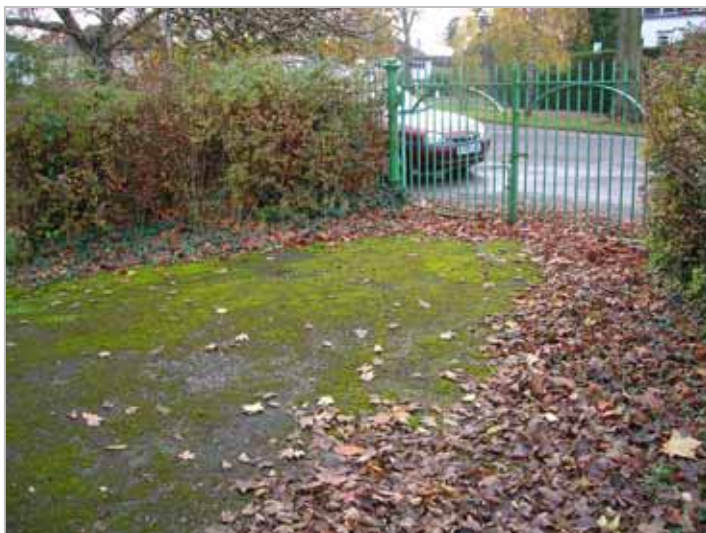
2007 Gates onto Pittville Lawn

To the east of the lower lake are two further gateways, the most eastern of the two leads off Pittville Lawn, between medium height green iron gates, towards the bridge to the east of the Upper Lake. These gates are locked.

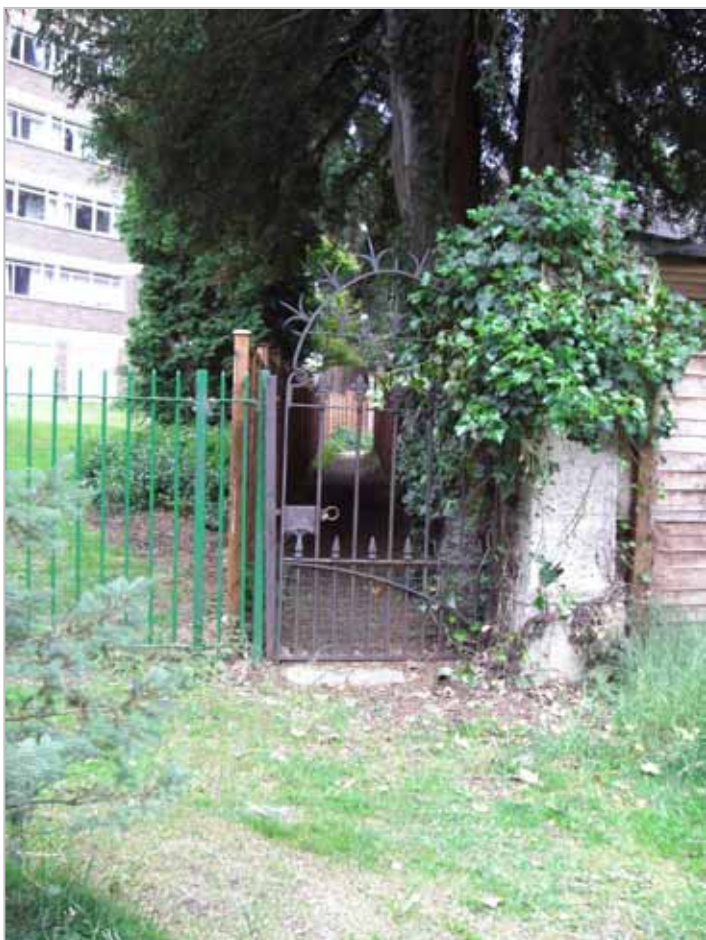
2007 Entrance along eastern boundary of Pump Room lawns

There is a small pedestrian entrance to the east of the Pump Room lawns which has an ornamental gate. A narrow alley leads east between the gardens of residential properties and finally emerges onto Albert Road.

It is unclear as to the history of this entrance and the amount of visitors to the park who use it. The ironwork of the gate is different to the site wide style of ironwork which may indicate it was once a private, locked entrance to the park.

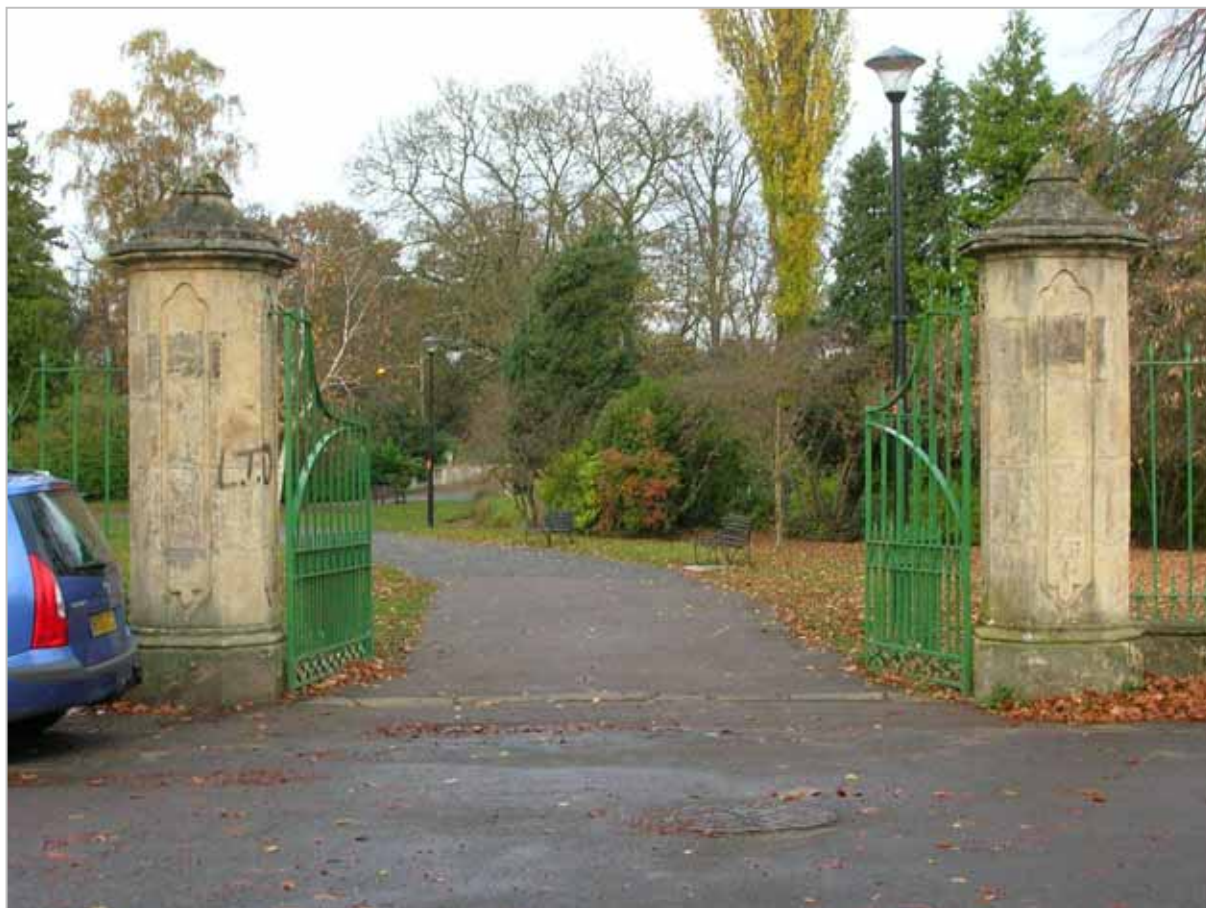
2007 Gates to south of Upper Lake

The grand, formal entrance for the carriage drive to Pittville Pump Rooms is found to the south of the Upper Lake, off Pittville Lawn. Two high, stone gate piers with finials define the gateway and a pair of high green iron gates stand open to welcome visitors. A hard, bitmac surfaced, drive leads through the gate piers, looping around the eastern side of the Upper Lake, across the bridge and north towards the Pump Rooms. This grand entrance is an indication of the historic significance of the park. There is no interpretation of this historic significance at this point.

For a short distance beyond the gate piers, continues a low, curved stone wall with green iron railings above. The low wall ends with a further set of smaller piers. To the east a medium height, green iron railing fence defines the park boundary. To the west the park is open. Parked cars to either side of this significant and important gateway detract from its character.

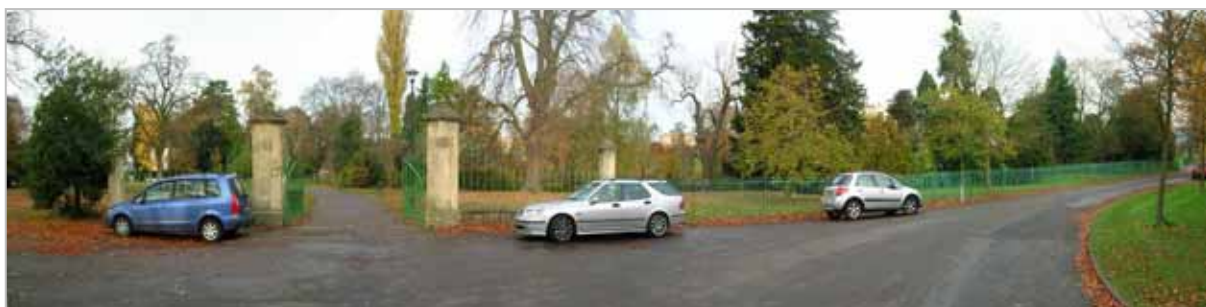
2007 Car parking around gates

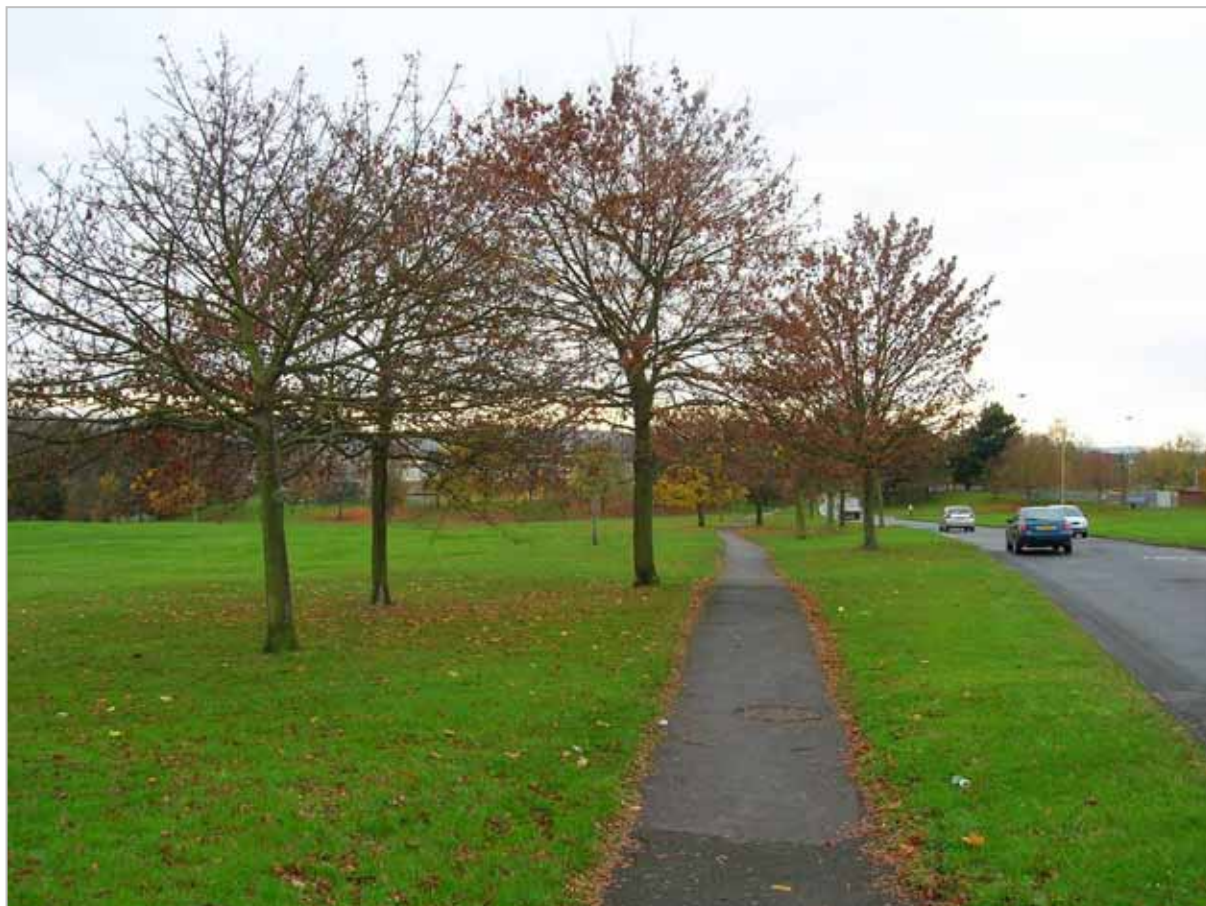
2007 Open access into Pittville Park off Tommy Taylor's Lane

To the west, predominantly open boundaries enable pedestrians and cyclists easy access along the majority of the boundary. Hard surfaced footpaths are lacking to the west, with the only routes running west-east along the lakeshores. Gateways along the southern boundary with the St Paul's residential area enable easy access, despite the lack of footpath provision and desire lines within the grass are a clear indication of usage.

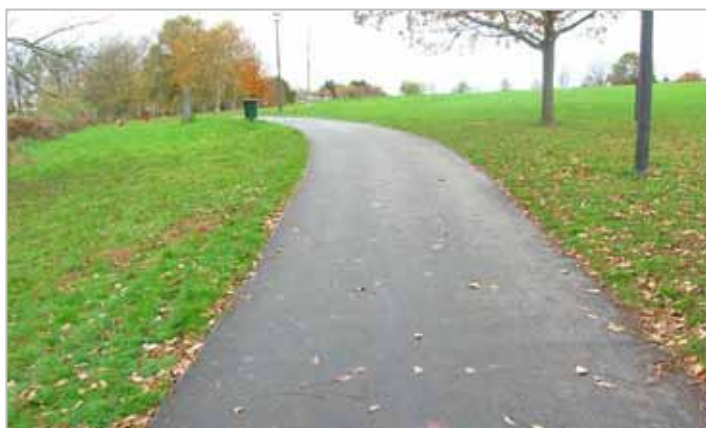
2007 Footpath west towards Tommy Taylor's Lane.

Whilst there is easy access for cyclists within the park, footpath provision is limited and the only route through the west park is via a relatively narrow footpath, wide enough for pedestrians to pass with ease but too narrow to allow safe passing of pedestrians and cyclists.

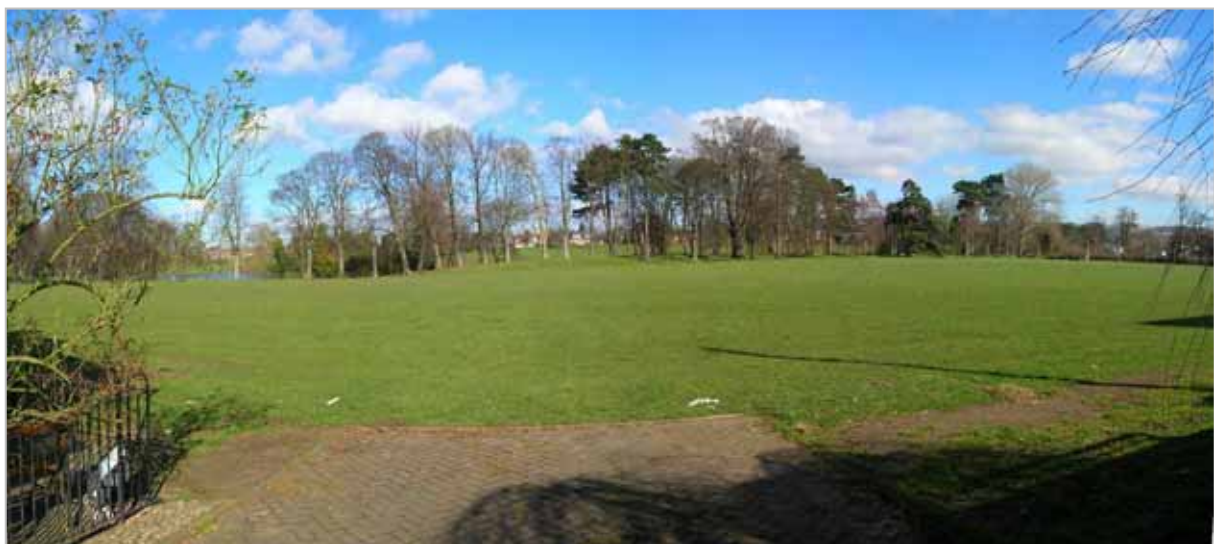
2007 Gateway entrance into park with dirt track off to the right.

The gateway to the west adjacent to Agg Gardner Lodge leads from Brunswick Street. There is a brick surfaced footpath between the road and the park, which ends abruptly just beyond the rear garden boundary fences of adjacent houses. A dirt track, formed through volume of foot traffic, leads off east at this point towards the newly renovated Agg Gardner Pavilion.

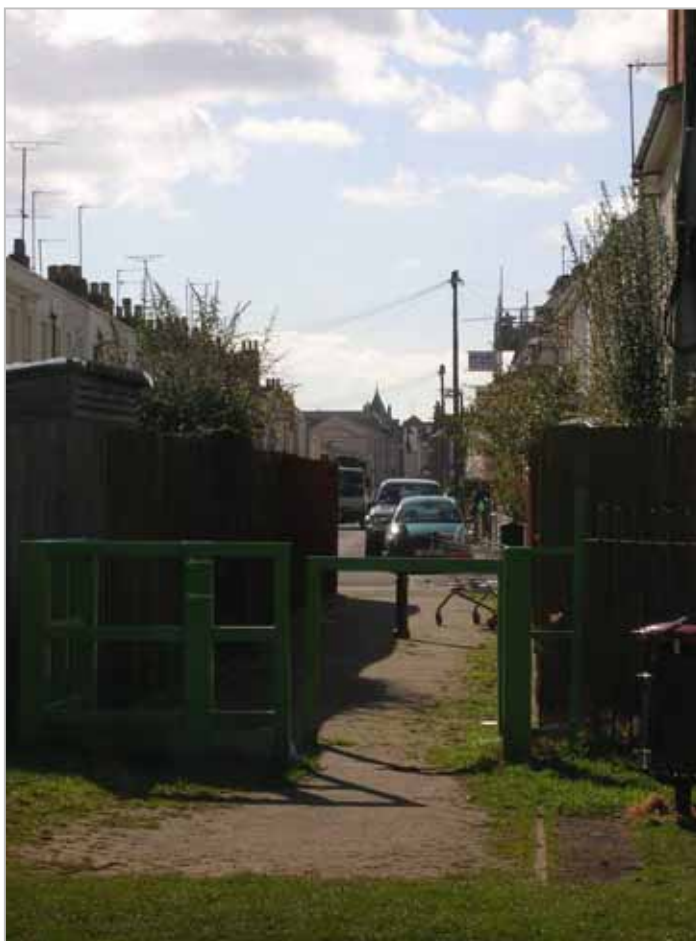
2007 Gateway between park and Marle Hill Parade.

The central gateway from Marle Hill Parade leads into the park between residential houses. This gateway space is narrow and difficult to see both from the park and from the road to the south, and is defined to the north by solid green metal railings with pedestrian access space between.

To the south a single black bollard stands in the centre of the footpath. This gateway has a brick surfaced footpath which is colonised by grass and weeds. Again the path ends abruptly once inside the park. High wooden garden boundary fences stand to each side of this narrow gateway space.

Despite the provision of a rubbish bin, there was, at the time of surveys in the park, a large amount of rubbish surrounding this gateway.

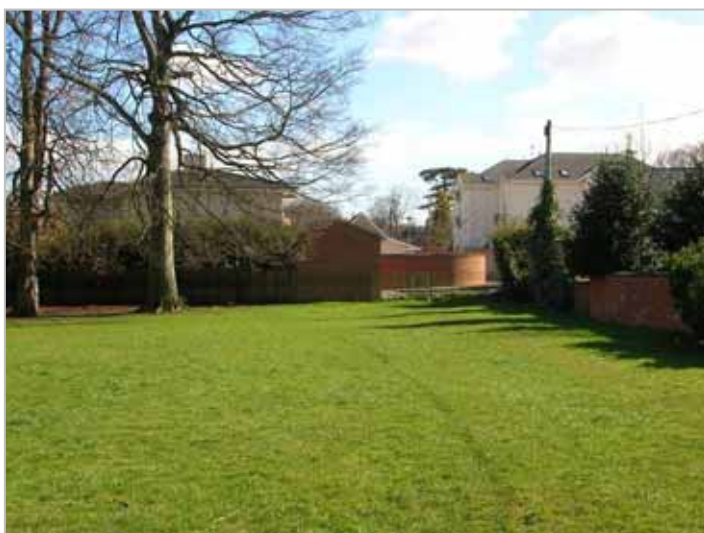
2007 Eastern gateway into park from Wellesly Road.

The third gateway to the east of the Agg Gardner recreation ground leads from Wellesly Road and enters the park via a low iron railing fence and gate.

This gateway runs to the east of the residential houses and has a more open aspect. Again, there is no hard surfaced footpath leading into the park from this gateway although clear desire lines within the grass give an indication of foot traffic through this gateway.

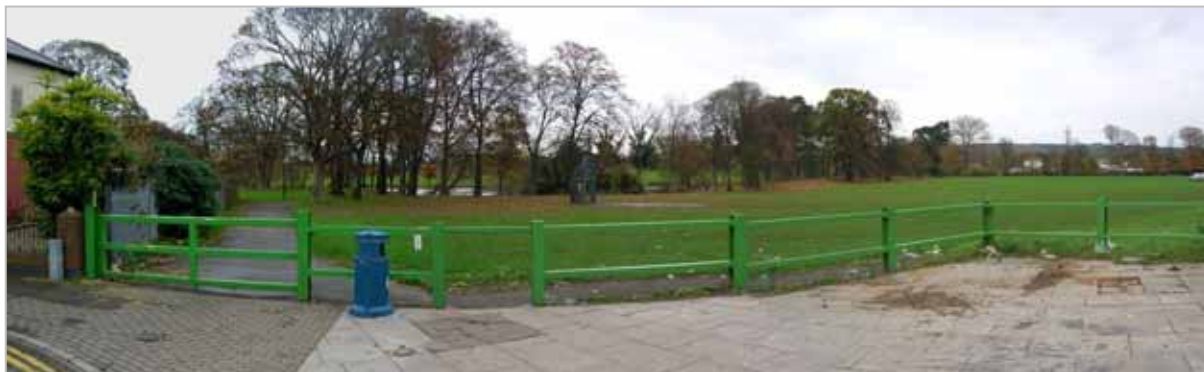
2007 St Paul's gateway looking north (above) and south (below)

The main St Paul's gateway does have a hard bitmac surfaced footpath leading towards the Lower Lake, through a green metal fence designed to prohibit the entry of traffic into the park. Sadly it also gives the visual appearance of no access from that point and it is only when close by the fence that entry points can be seen. There is a gate which opens into the park, allowing authorised maintenance vehicles entry.

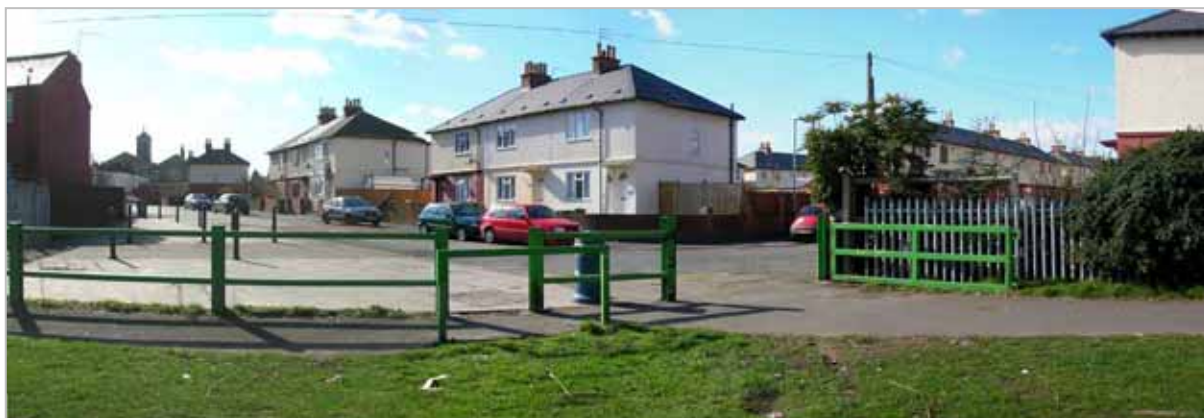
This gateway, which leads into the park from the junction between Hudson Street and Hanover Street, is the least appealing of all within the park. Litter and broken grass are strewn in the ground.

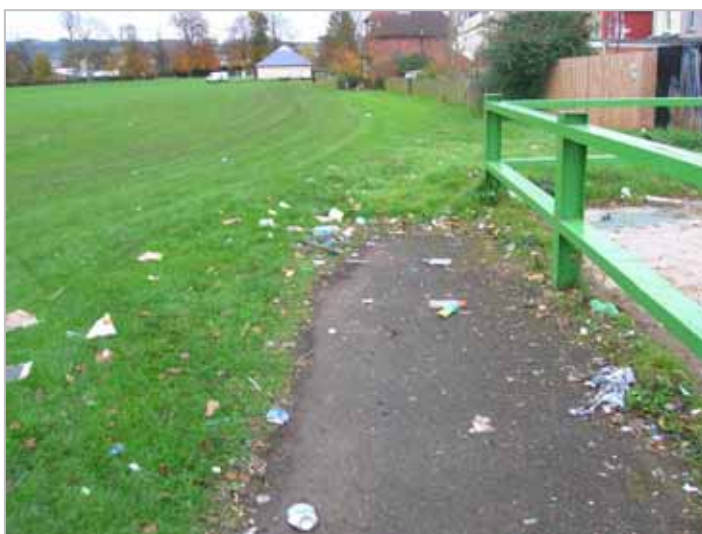
2007 St Paul's gateway

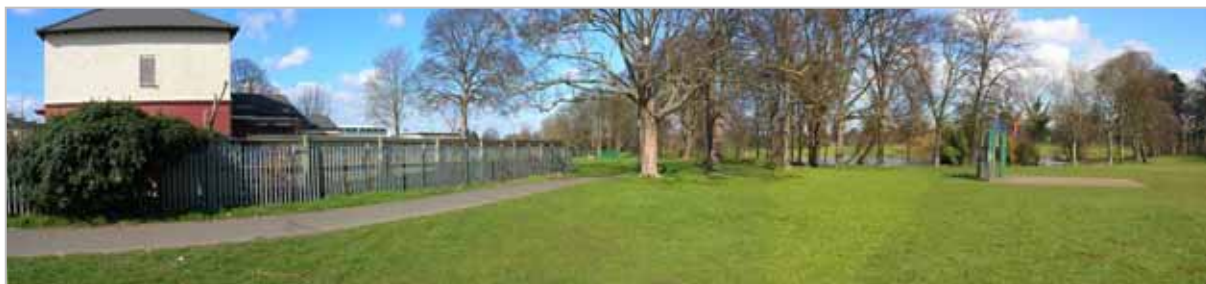
2007 Footpath.

A single narrow bitmac surfaced footpath leads from this gateway, adjacent to a high metal security fence towards the Lower Lake.

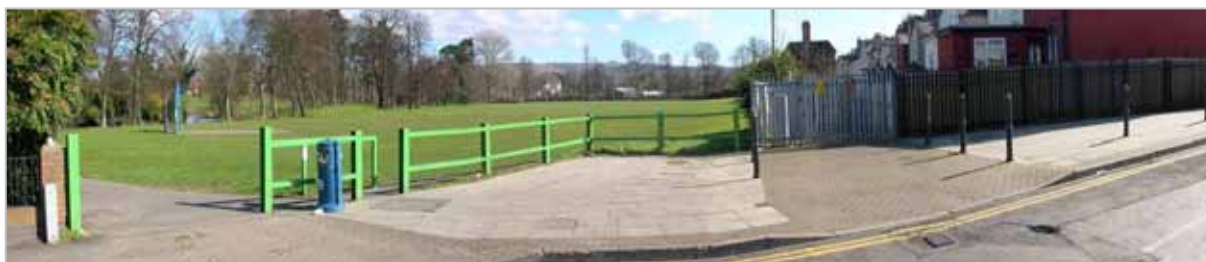
2007 South of the gateway.

To the south of the gateway there is an expanse of hard surface. This is paved with both pc slabs and an area is also paved with smaller units to denote the entrance to an electricity sub-station. This variety of paving styles results in an untidy appearance which does not contribute to the character and setting of the park. Bollards have been erected to restrict the parking of unauthorised vehicles, although consultation with local community groups indicated that this is a sensitive area and often covered in parked cars whose occupants cause damage around this gateway and within the park.

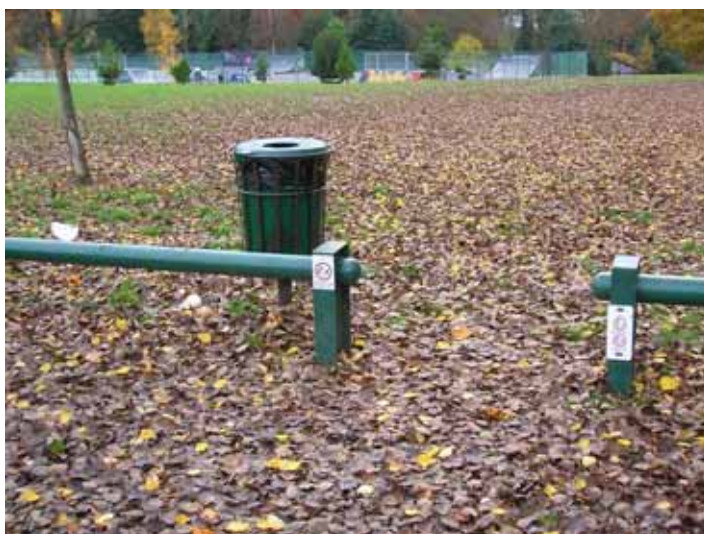
2007 Access into park via Albermarle Road car park

The gateways adjacent to the Albermarle Road car park is marked by two gaps in the low fencing which surrounds the car park. There is no hard surfaced footpath linking these two entrances beyond the car park, however, as this is the only exit point from the park towards the north, there are clear desire lines in the grass indicating the extent of foot traffic. There is no gateway to the north eastern part of the park and the boundary is marked by a high evergreen hedge along Albermarle Road and higher golf netting along Evesham Road.

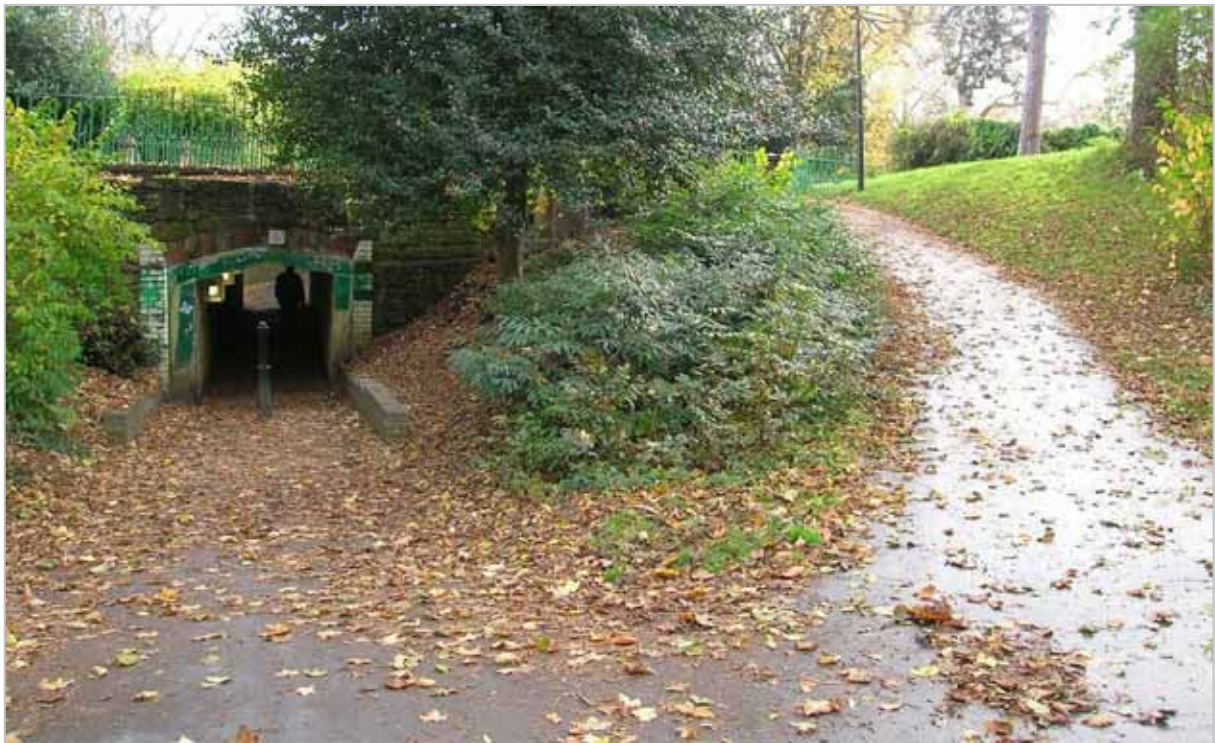
2007 Access into the park off Evesham Road.

Further south along Evesham Road, beyond the subway, is a narrow gateway between the green iron railings. A hard, bitmac surfaced path leads west towards the Lower Lake. This is the main access point into the western park from Evesham Road. There is no signage at this point which announces arrival into the park.

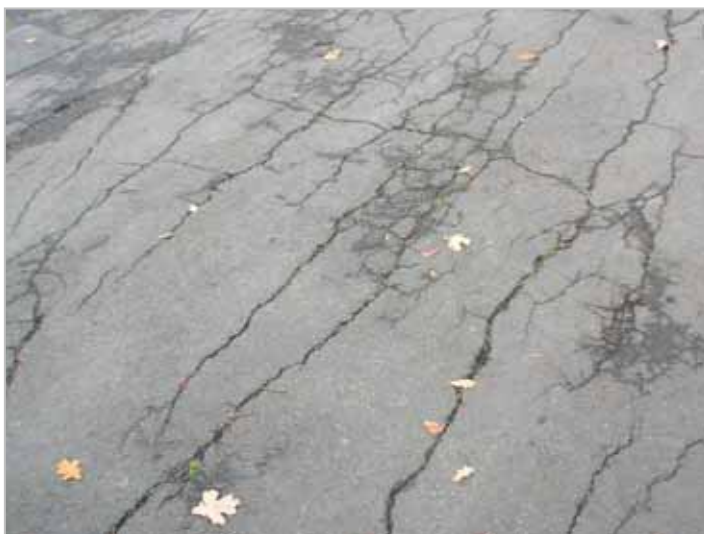
The footpaths and drives in the eastern park comprising Pittville Pump Room Lawns, Upper Lake and Pittville Lawns are, predominantly of a hard, bitmac surface. These footpaths are in generally poor condition with surface cracks noticeable in some areas of the park. They have been spot patched in places to prevent pot holing in the short term.

The most common disruption of the bitmac surface is caused by tree roots. This disturbance can create a surface which is uplifted and folded which may cause a tripping hazard for park users

2008 Cracked surface on Pump Room Drive

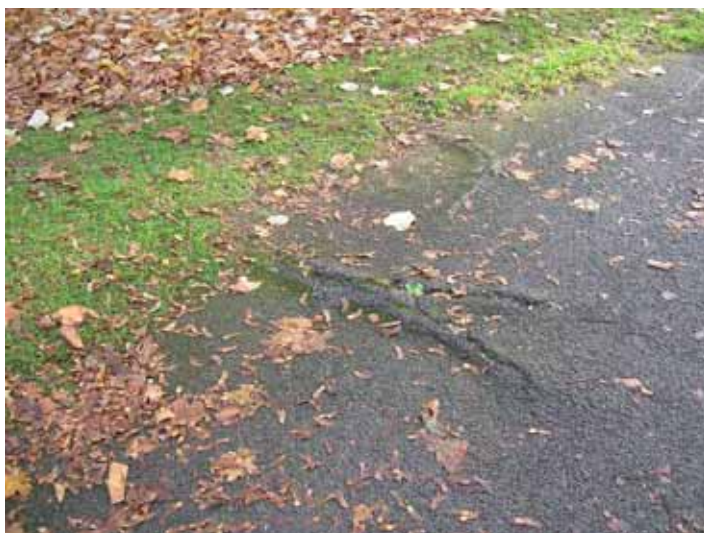
2008 Path surface disturbance

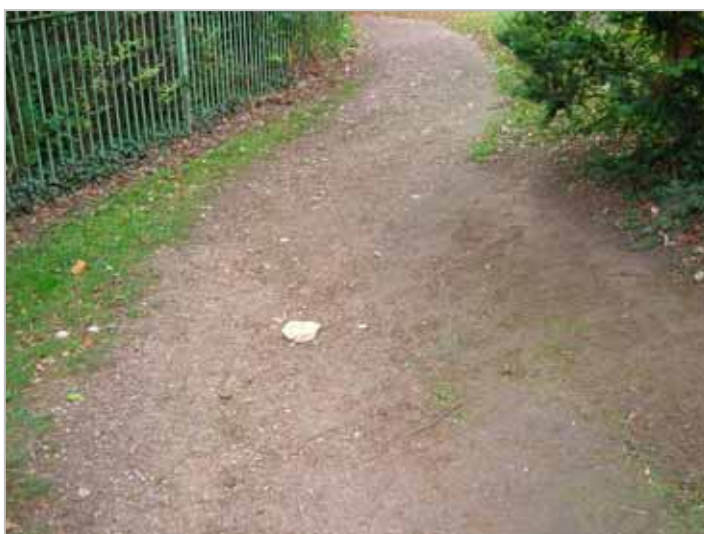
The narrow path leading around the southern lakeside is surfaced with a compacted gravel and has visible signs of deterioration from foot traffic, further enhanced when the lake floods.

2008 Footpath to the south of the Upper Lake

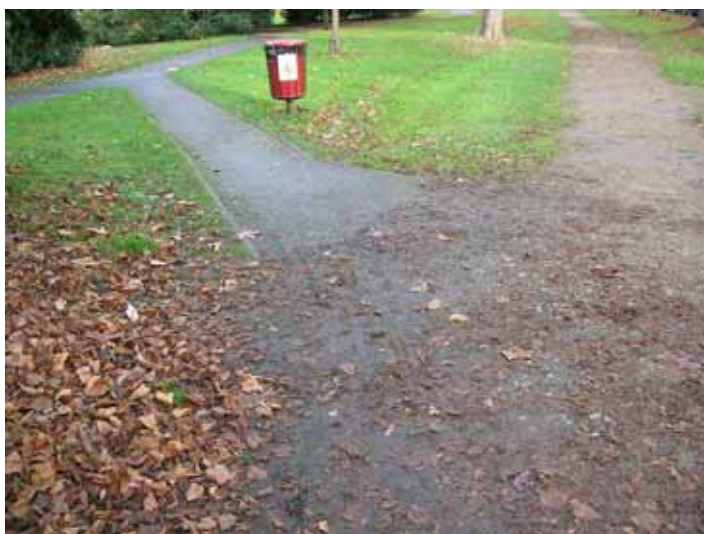
2007 Pittville Lawn North

The footpaths surfaced with compacted gravel which run adjacent to Pittville Lawn and Central Cross Drive also show an amount of surface deterioration, and indicate the amount of foot traffic through this area.

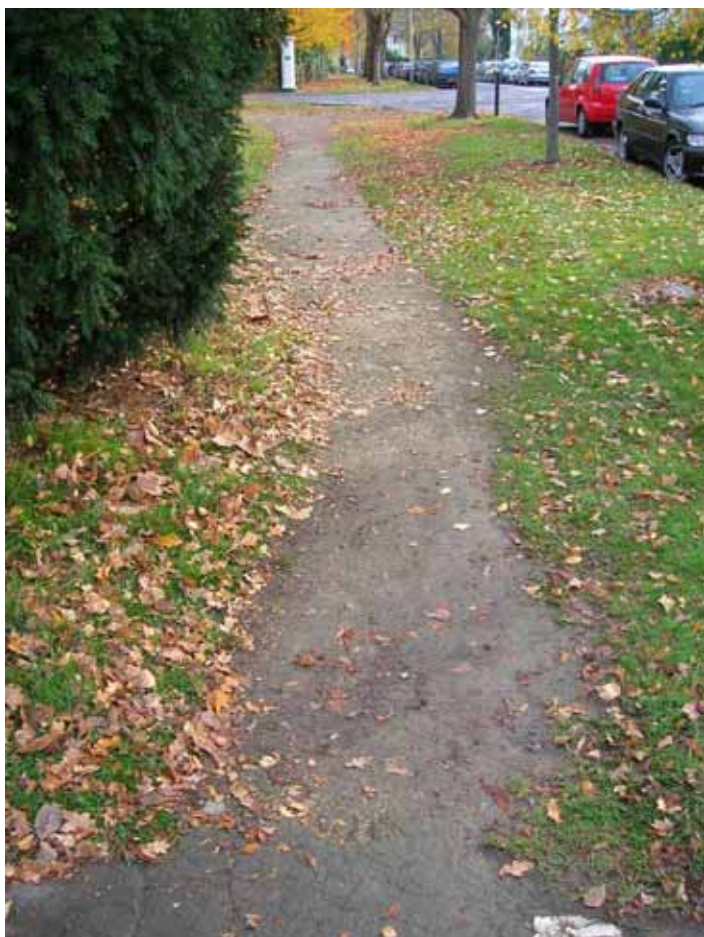
Some paths appear to have no surface treatment, or if they did the surface has disappeared. There are now desire lines which have, through the amount of use, worn a dirt track through the grass. These paths are an indication of the regular routes which people take through the park, especially where there are links to adjacent hard surfaced footpaths.

Such paths look untidy and are not in keeping with the setting or character of the park.

2007 Dirt track adjacent to Central Cross Drive

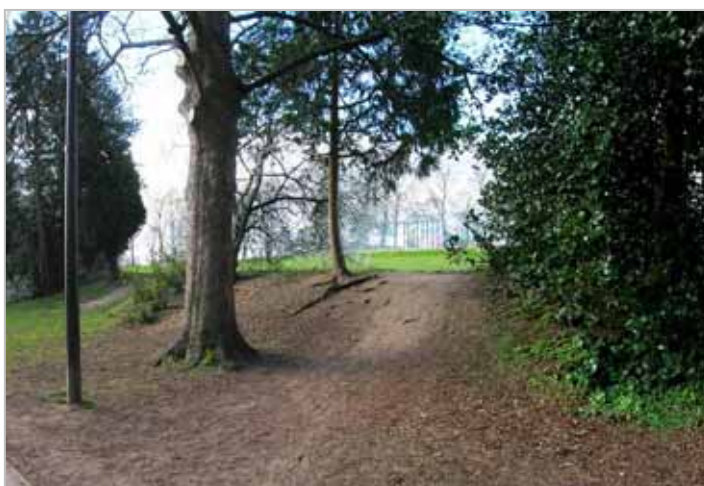
There are well worn desire lines which meet this path, the most prominent being to the east of the Lower Lake adjacent to the boat house and tennis courts.

2007 Desire lines off the footpath around the Lower Lake (above and below)

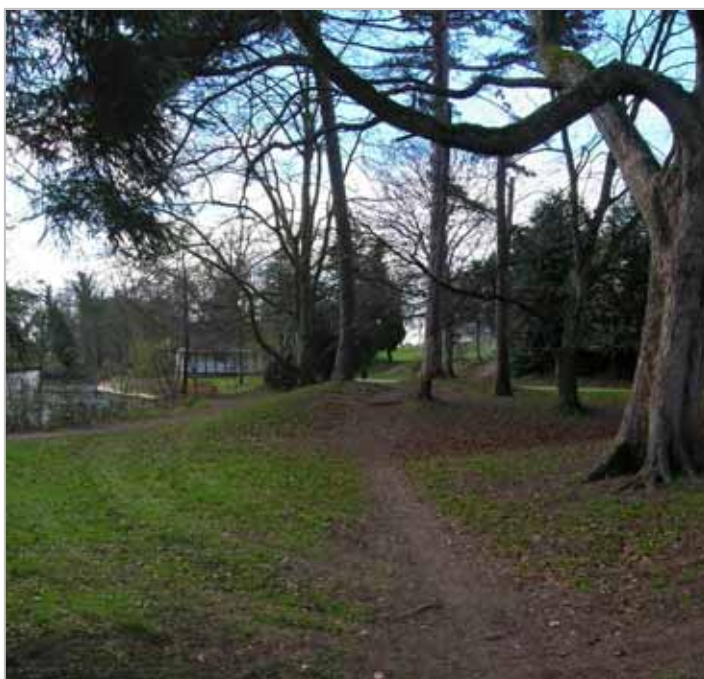
To the east of the Lower Lake where the footpath extends beyond a large grassed area, desire lines have been formed by people taking a shortcut across the grass, resulting in the grass wearing away and a dirt track established.

In the gateway space to the Lower Lake, this surface deterioration does not add to the character and setting of the park, instead it gives a weary and neglected appearance.

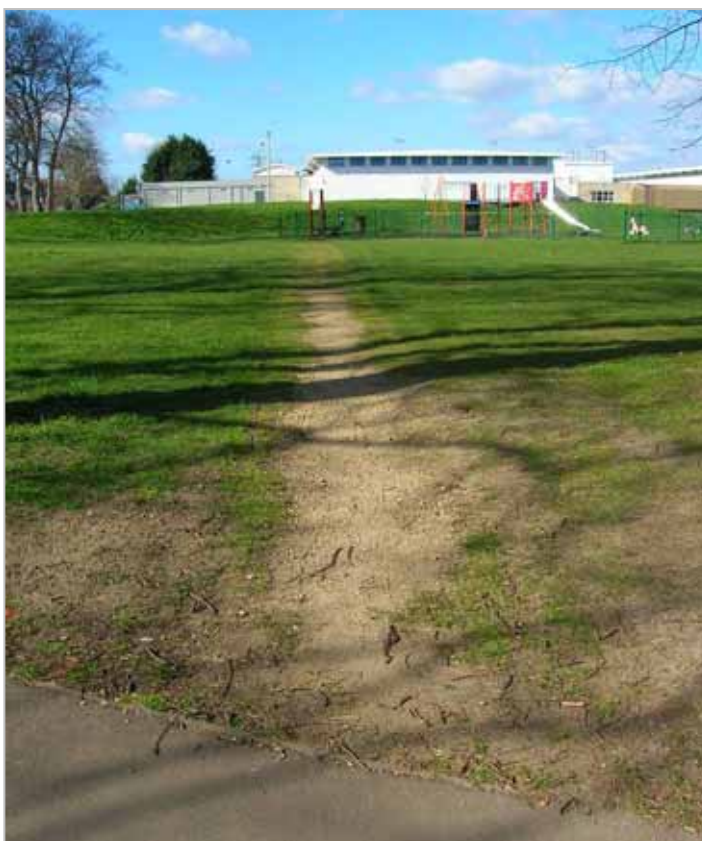
2007 Play area adjacent to the St Paul's residential area

A similar desire line has been worn into the grass towards the children's play area adjacent to the St Paul's residential area. Originally a gravel surfaced path, the edge is just visible although grass has been allowed to encroach and the surface disappeared.

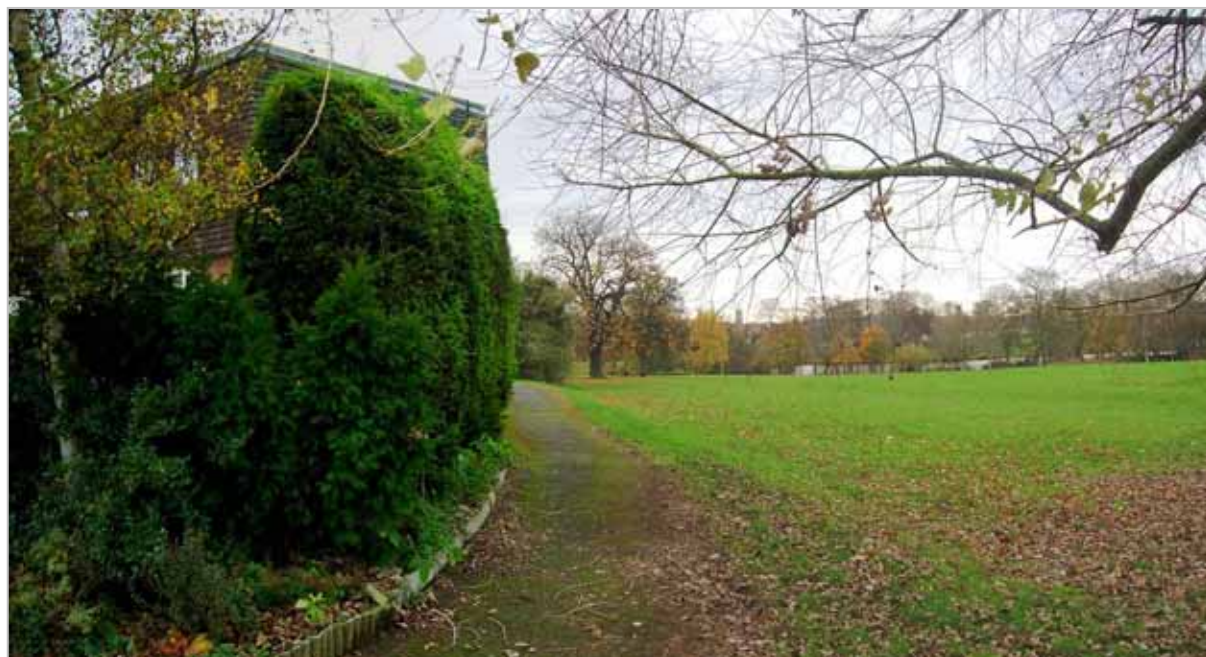
2007 Residential area footpath off Albermarle Gate

There is no hard surfaced footpath to the north of the west park. Grass runs directly adjacent to Albermarle Road, with the only footpath provision being to the north of this road. On the land once occupied by Marle Hill House, a narrow worn bitmac surfaced path runs around the perimeter of the residential houses. This footpath is outside the boundary of the park but is the only hard surfaced footpath available to park visitors at this northern boundary.

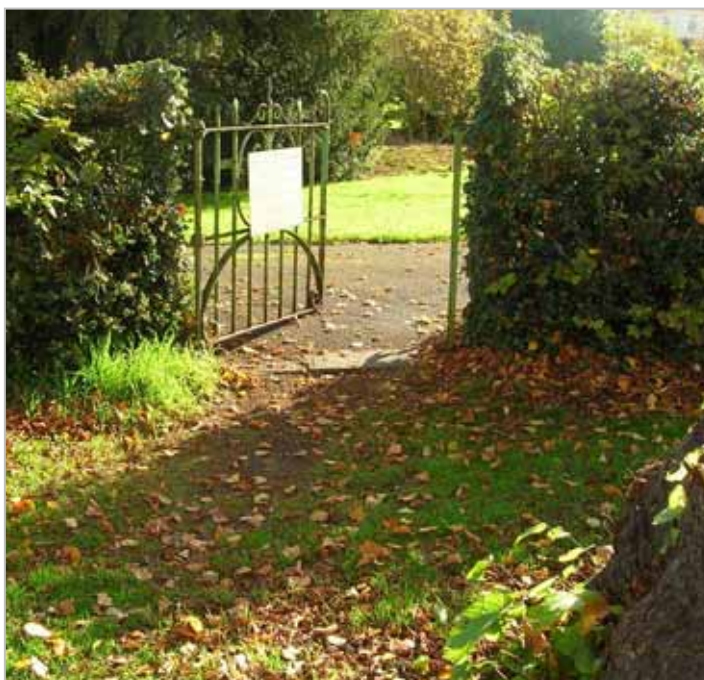
2007 Wellington Square

Footpath provision to the exterior of the boundary hedge is limited, with hard surfaces only provided close to the some of gateways. The hard surfaced footpaths do not extend to four sides of the squares and, where these surfaces end, the footpaths are still visible in the grass, either as a well worn dirt surfaces or as desire lines within the grass. The need for a footpath to the exterior of the boundary hedge is clear and the current worn grass surfaces do contribute a negative affect on the character and setting of these squares.

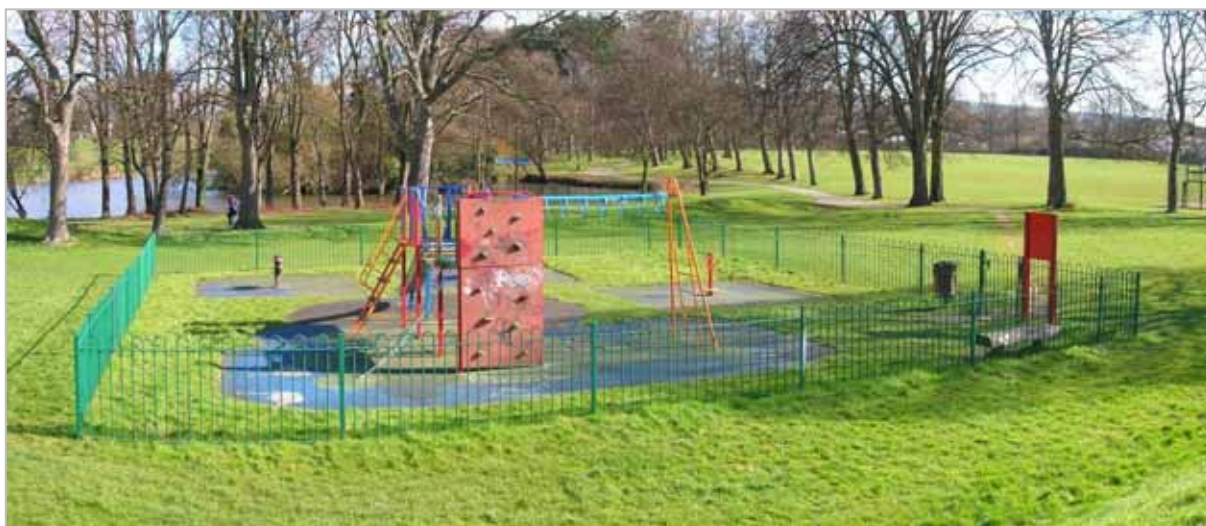
2007 Play area adjacent to the St Paul's residential area

The play area adjacent to the St Paul's residential area has restricted access. The fenced play area is an island within the grass, with no hard surfaced footpath leading to and from it. This lack of well maintained footpaths effectively limits access to this play area to dry weather only. At other times access across the grass, especially for tiny feet, will result in wet shoes. Disabled access to this facility would be extremely difficult.

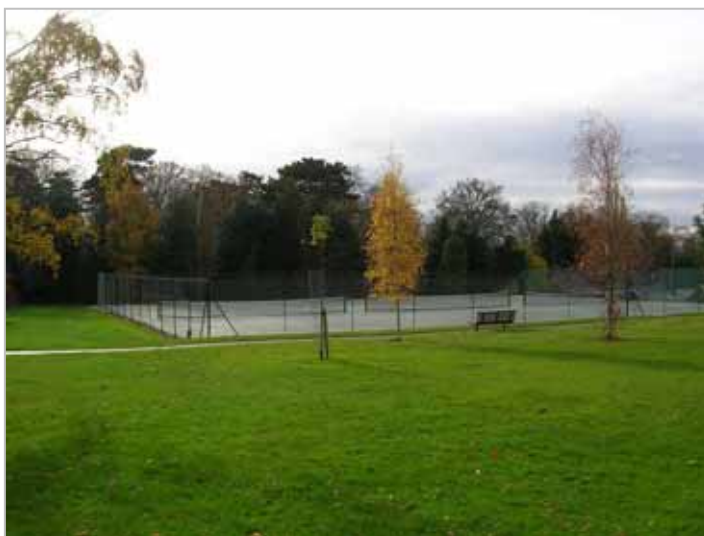
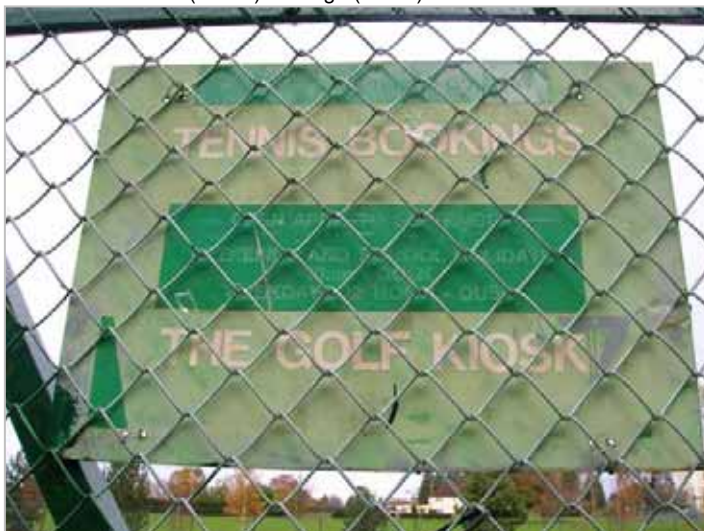
2007 Tennis courts (above) and sign (below)

A faded sign attached to the fencing to the south of the courts indicates bookings available between April and September at the golf kiosk, which no longer exists.

The entrance gates and steps, especially to the south, are in a poor state of repair and visually detract from the high quality surrounding landscape.

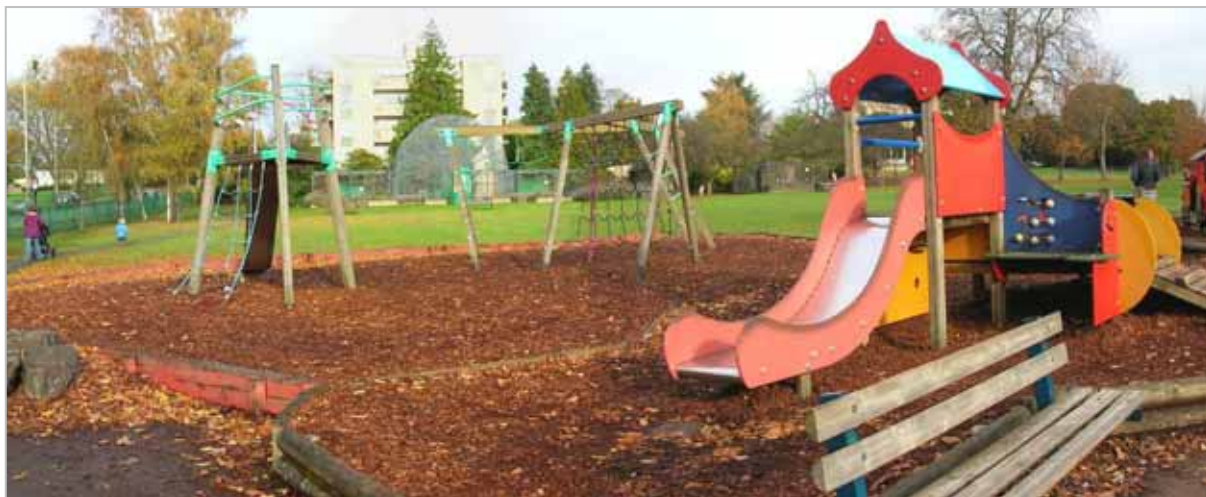
2007 Evesham Road play area

Metal self closing gates are installed in the gateways to both play areas. Large areas of dark coloured wet pour give the Evesham Road play area a drab and unappealing appearance. The wet pour surface in the St Paul's play area does have colouring upon it although this is becoming faded and worn.

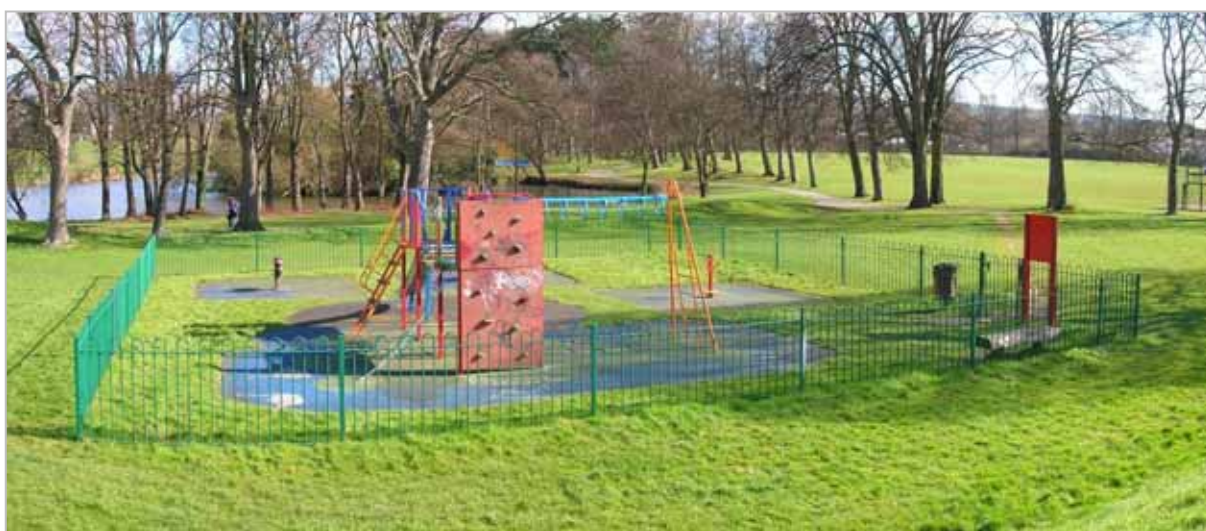
2007 Agg Gardner play area

Whilst the equipment is in good working order, it is becoming faded and worn with use, with path surfaces and edging treatments showing a high amount of wear and tear.

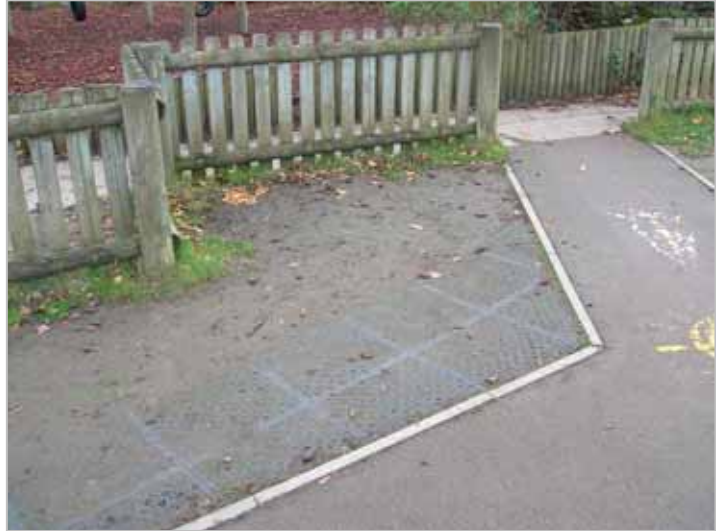
Some of the grassed surfaces within the Evesham Road play area have become very worn, despite the provision of grass crete surface. This is an indication of the usage of the play area.

2007 worn grass in Evesham Road play area

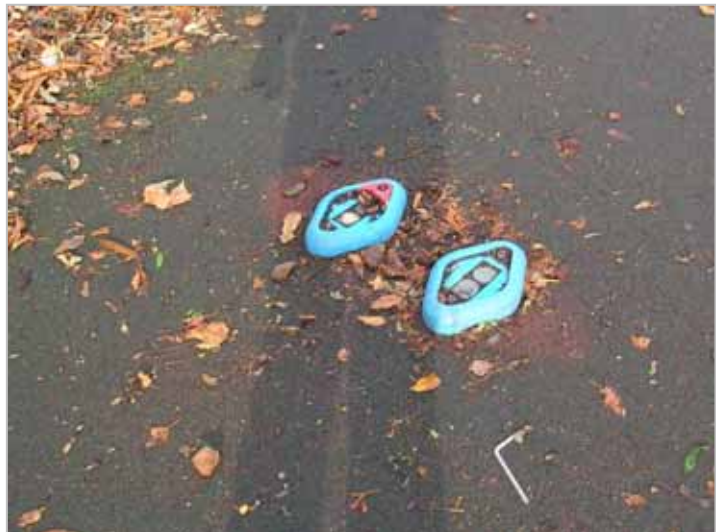
On the occasions of the site visits in November 2007, equipment was rocking equipment had been removed from the wet pour surface.

2007 Missing equipment

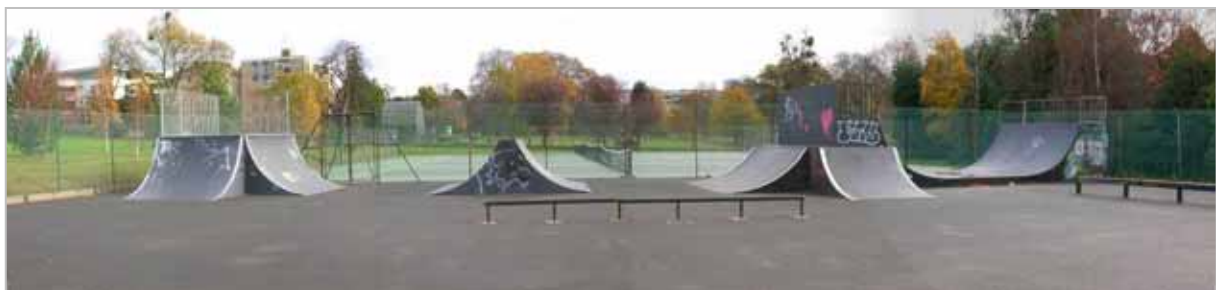
2007 Skateboard park looking east

Teenage provision within Pittville Park is specifically provided by a skateboard park. This feature has been built within the perimeter fencing of former tennis courts adjacent to the existing tennis courts adjacent to Evesham Road. There is a good range of equipment provided for both skateboard and BMX bikes.

While surface treatment within the area is structurally sound, it is considered far from useable by user groups. The equipment has a large amount of graffiti which is visible from a distance across the western park and from Evesham Road. This visually detracts from the character and setting of the park.
