SECTION 5 – VULNERABILITY AND ISSUES

5.0 VULNERABILITY AND ISSUES

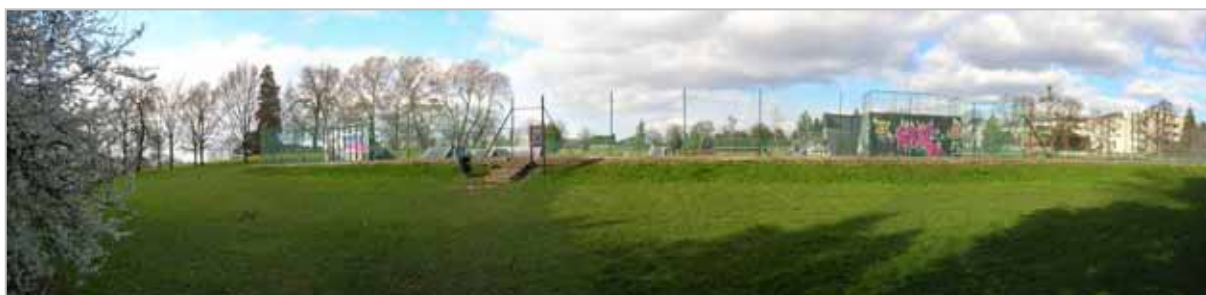
2007 Skateboard park from south

While surface treatment within the area is structurally sound, it is considered far from useable by user groups. The equipment has a large amount of graffiti which is visible from a distance across the western park and from Evesham Road. This visually detracts from the character and setting of the park.

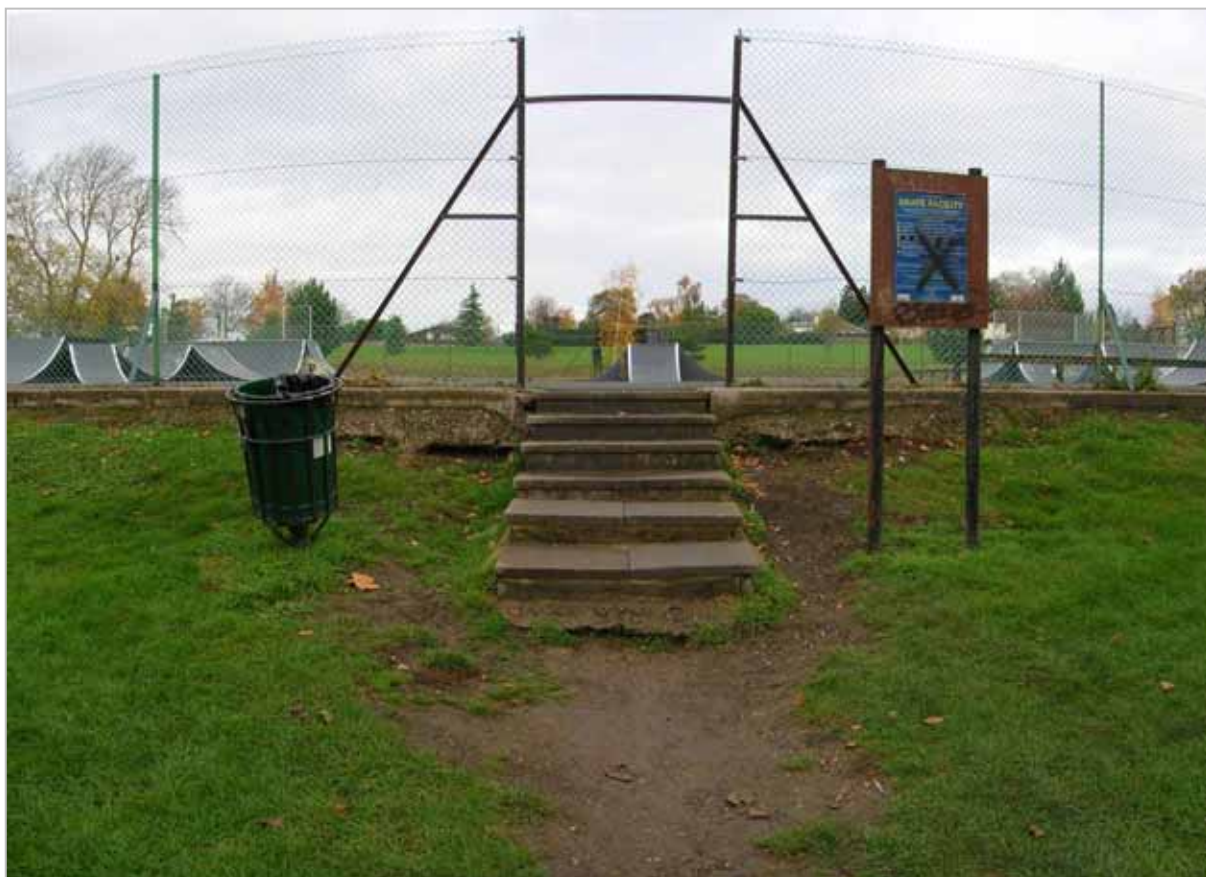
Access from the south is across grass from the Lower Lake path. Significant desire lines indicate the preferential route into the skateboard park. The steps and edges to the area are in a poor condition and give the appearance of neglect.

2007 Southern gateway to skateboard park

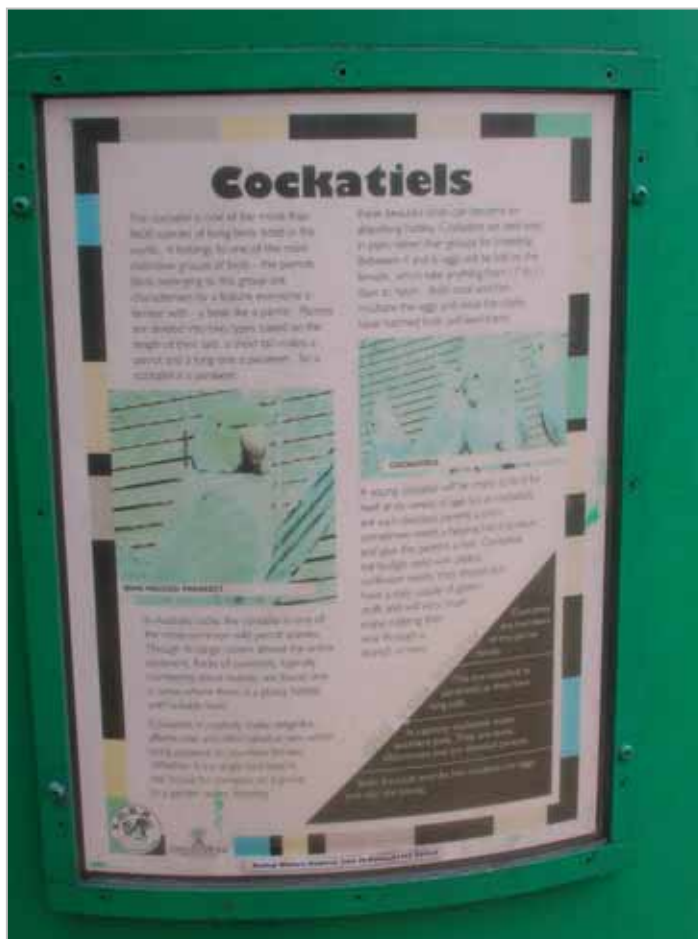
2007 Interpretation board adjacent to the aviaries.

The only area where an interpretation panel is provided is adjacent to the aviaries in the eastern park. Here a tall, green, circular information point gives relevant information regarding the animals and birds currently housed within the aviaries.

This information point looks uninviting and is above child's eye level, making information gathering extremely difficult for the younger visitors to whom these facts are primarily aimed. The graphics and text are more appropriate for an older age range and have faded considerably in the sun.

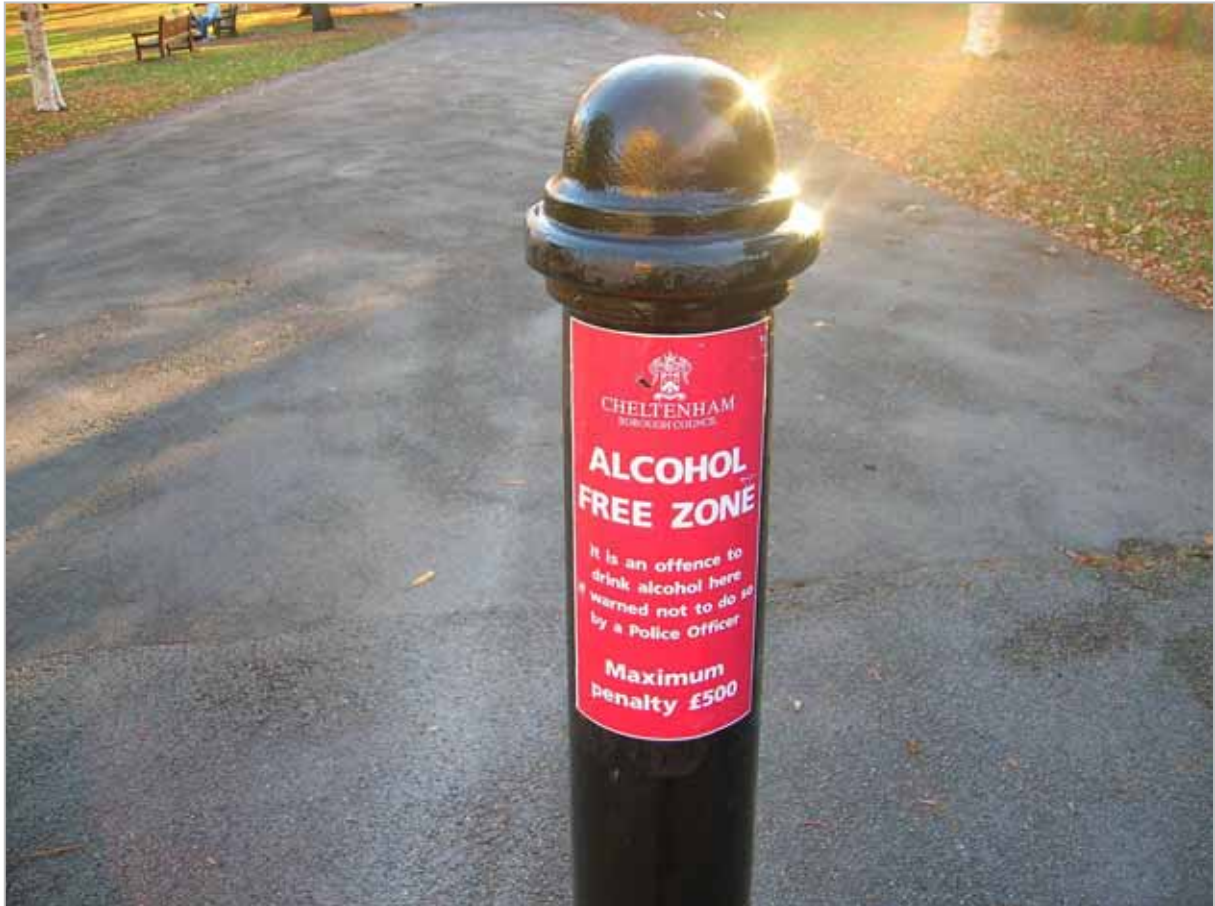
The signs vary in age across the park and are becoming worn and dated. Various stickers have also been randomly attached to signs or bollards, litter bins, fences and gates. The overall effect is a variety of styles, which are inappropriate to the character and setting of this important historic park.

2007 Stickers on bollard (above) and fence (below)

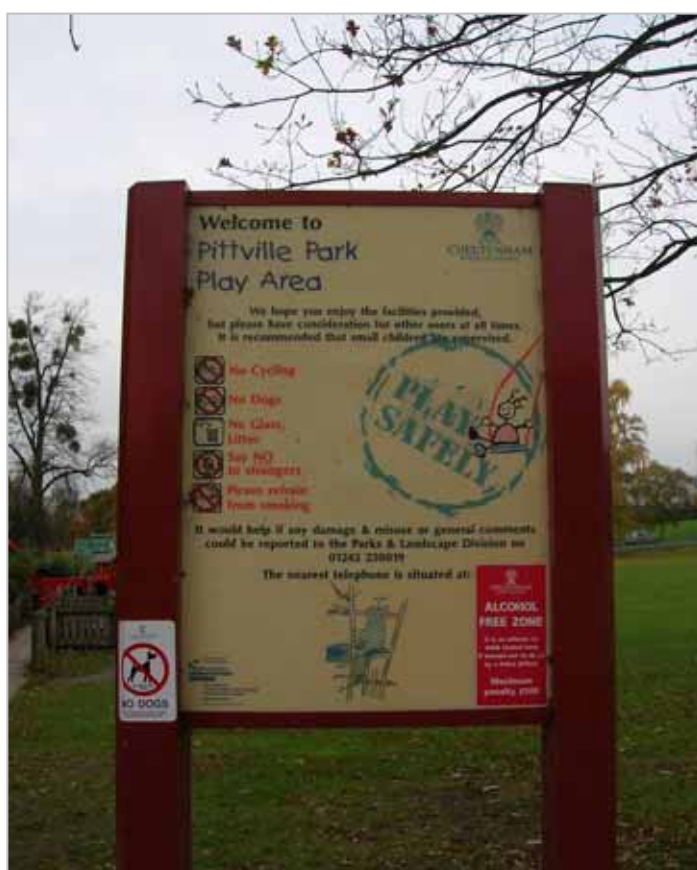
A sign which welcomes the visitor to the play area in the eastern park advocates safe play, however, portrays a negative message about what the users cannot do. Stickers have also been placed on this sign which gives a cluttered appearance and detracts from other important information.

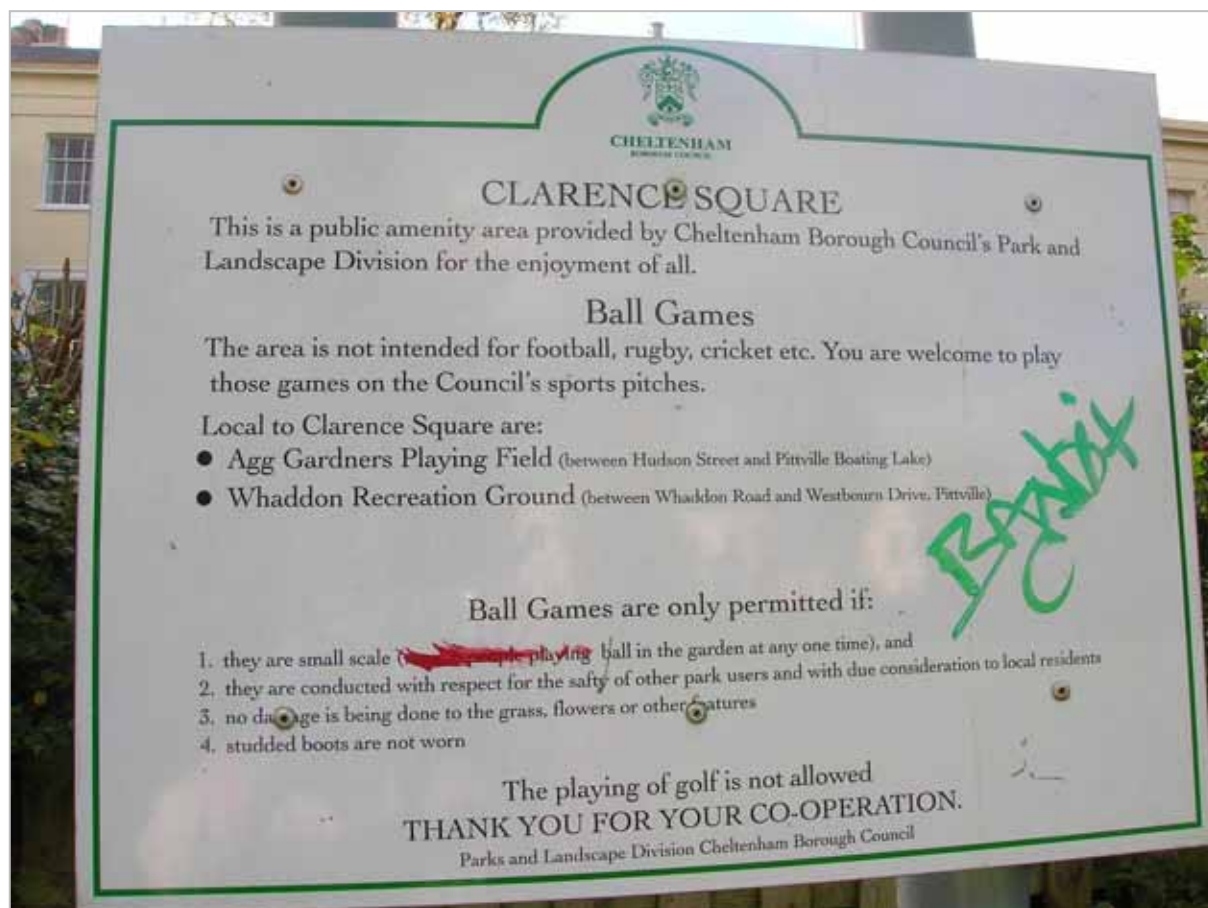
2007 Clarence Square sign (above) and random signs attached to railings (below)

Signage is again poor, with the two squares having similar signs which announce they are a public amenity area. In Clarence Square a rectangular metal sign is held in position by two metal tubular supports. The fixing points through onto the tubular supports have been drilled through text and the sign has graffiti upon it. The same sign appears again in Wellington Square.

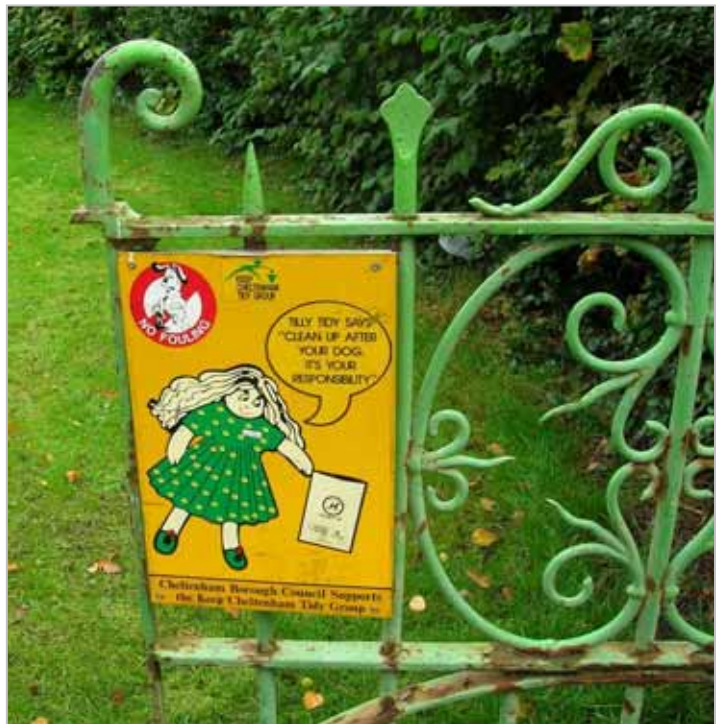
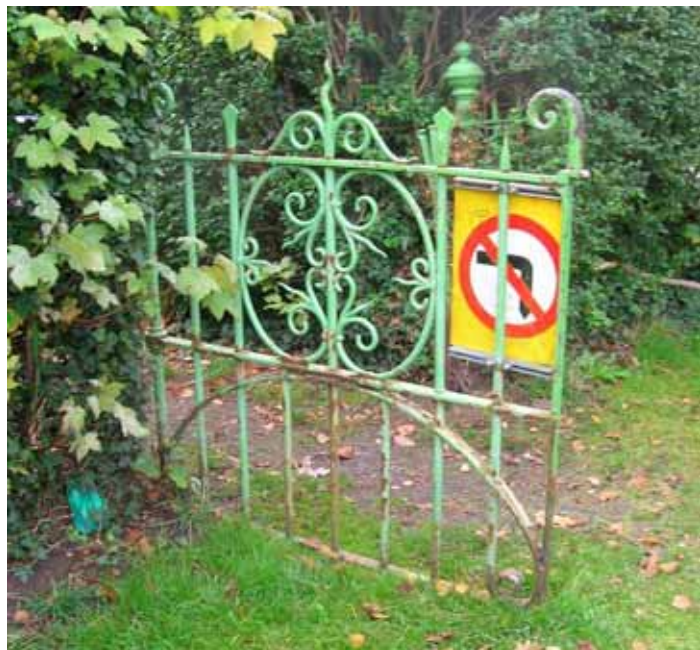
2007 Pittville Crescent sign front (above) and rear (below)

To the south of Pitville Crescent South is a small gate leading out onto the roadside verge. Here a sign has been attached to the gate. Once again this sign is of random design, visually intrusive and is attached to characteristic ironwork found within the park.

To the front the sign is clear in its message but to the rear another message is displayed which it out of place within this historic setting.

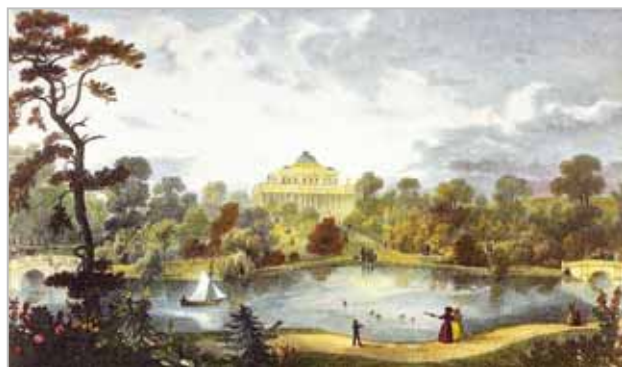
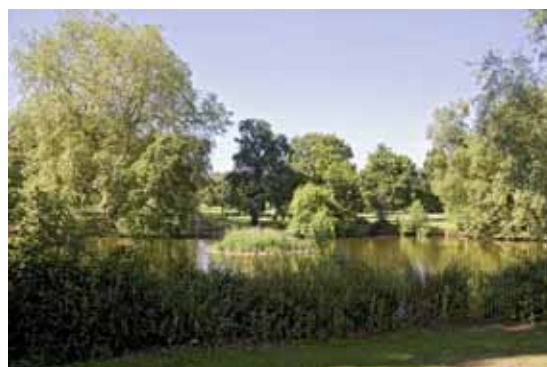
The most important vista within the park is that to the Pump Rooms from the upper lake. Once a clear view through, today, mature trees and vegetation have blocked the view.

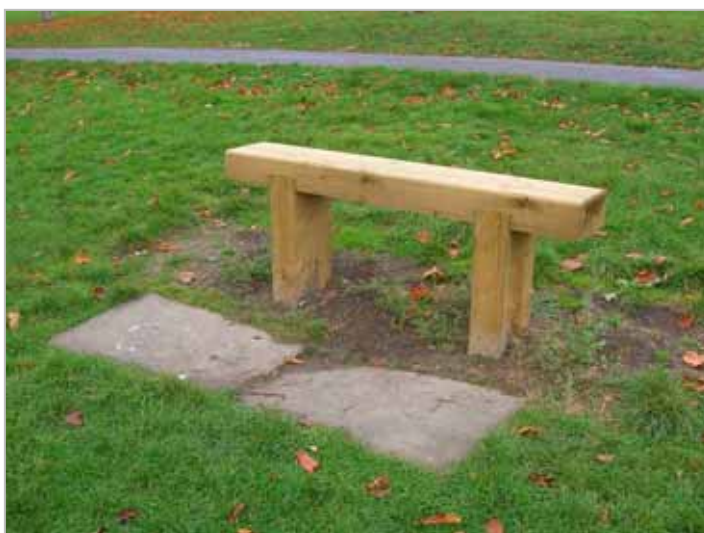
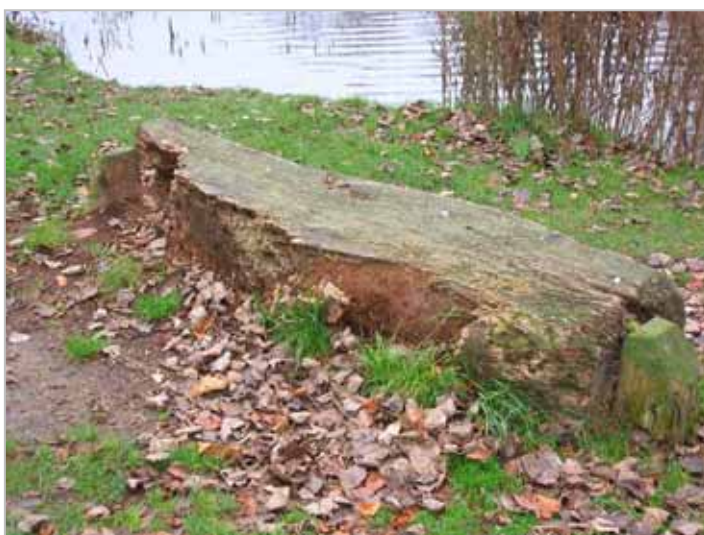
However, to the west park, seating opportunities are limited to the lower lake area with occasional fallen trees and only two simple benches provided on the north shore.

2007 Seating opportunities around the lower lake (above and below)

The use of fallen trees as a seating opportunity is to be commended as a sustainable approach to management and maintenance of the park, however if such features are to be used for seating, they must be maintained to a high standard and be offered as an attractive opportunity to sit and rest within the park.

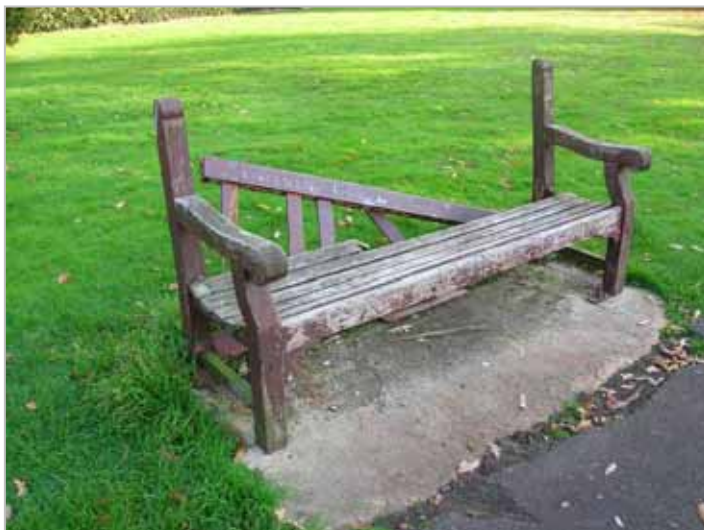
2007 Wellington Square

Seating opportunities are also very limited within the squares and crescents, with a single bench provided in each square and none in the crescents. The benches provided within the squares are increasingly covered with graffiti.

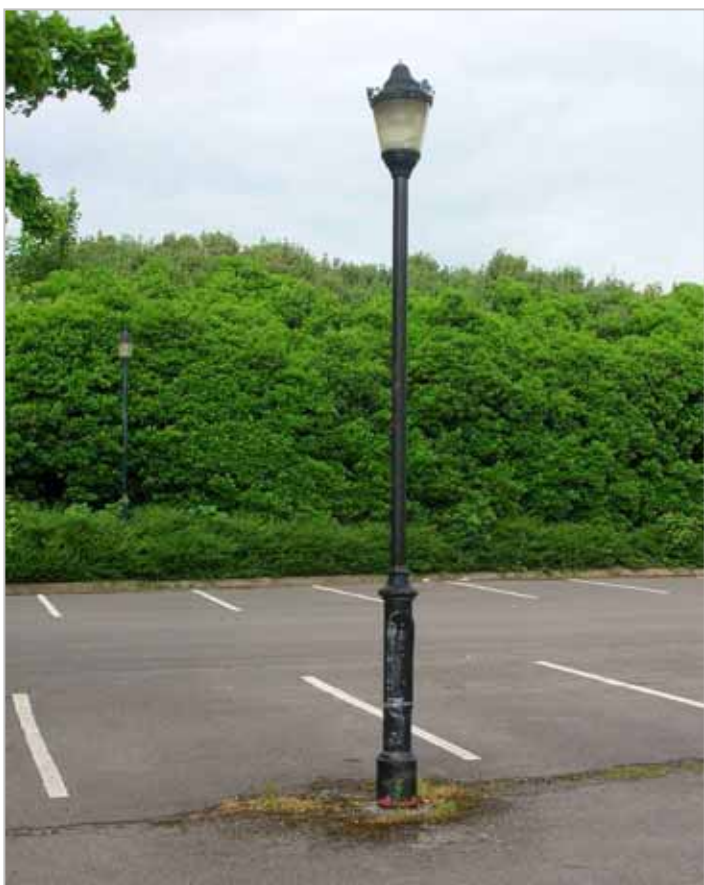
Lighting within the park is generally well positioned and maintained. The style of lighting unit is generally maintained throughout the park and units are predominantly positioned alongside footpaths and features such as play areas and buildings.

2007 Lighting in the Pump Room car park (above) and litter bin (below)

Litter bins within the park are located in predominant positions, generally alongside footpaths or other built features. They are generally of a standard style, coloured either green or red and the condition of these units varies according to age and usage.

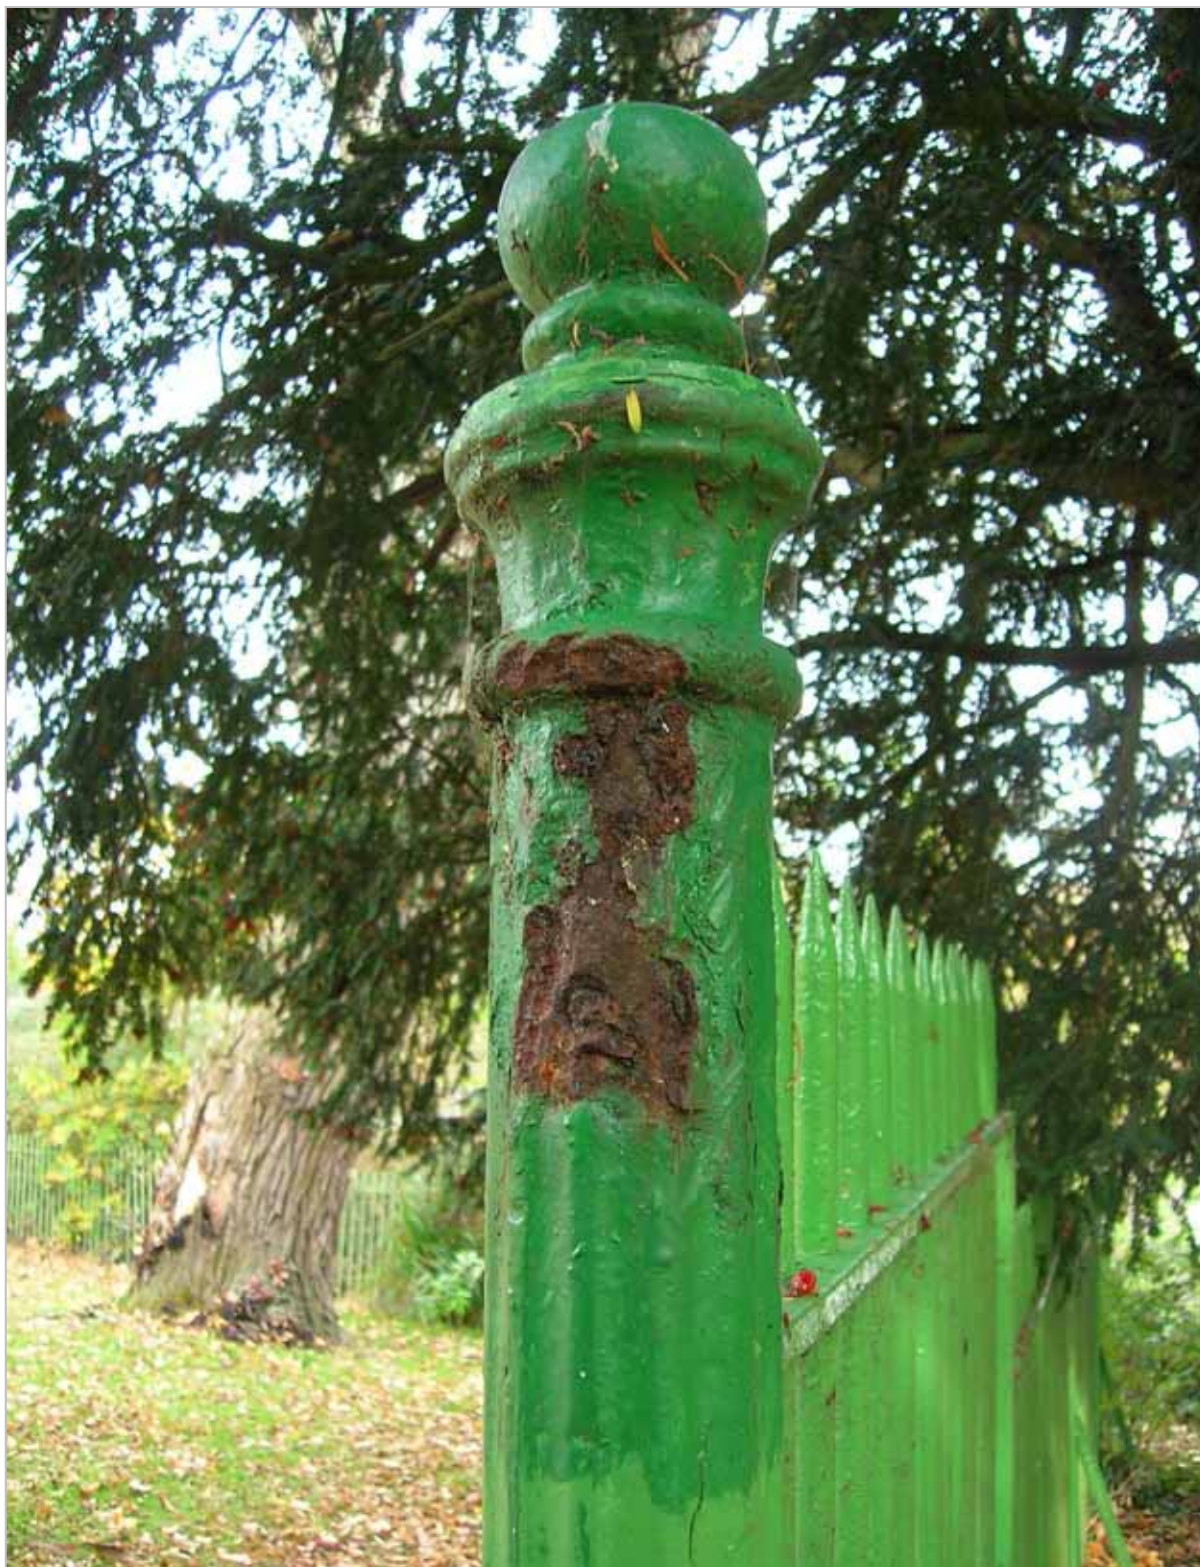
2007 Ironwork

The overall condition of the boundary treatments within Pittville Park varies according to style and age. The predominant style of built boundary treatment is green iron park railings. The current railings are replacements for original features which were removed during the 2nd world war and the condition of these features varies across the park. In some areas the paintwork is become damaged and the ironwork beneath exposed, resulting in rust.

Within the squares and crescents the ironwork has been removed and replaced with alternative styles of fencings, often simple wooden structures which are fit for purpose but not in keeping with the historic character and setting.

The condition of boundary elements such as railings and fences has been dealt with in detail in Section 3 and a condition survey of the ironwork in the park is attached at Appendix 3.

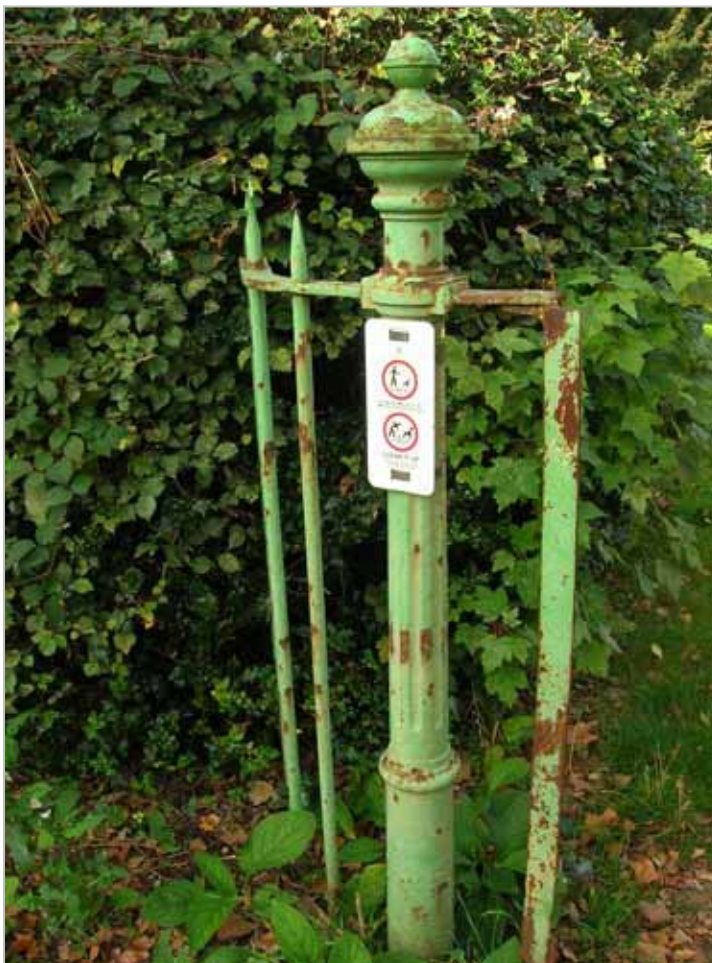
2007 Clarence Square

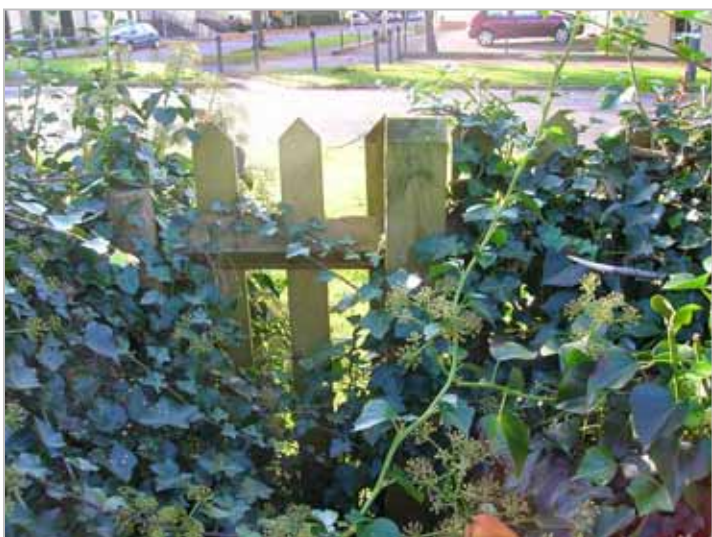
2007 Wellington Square

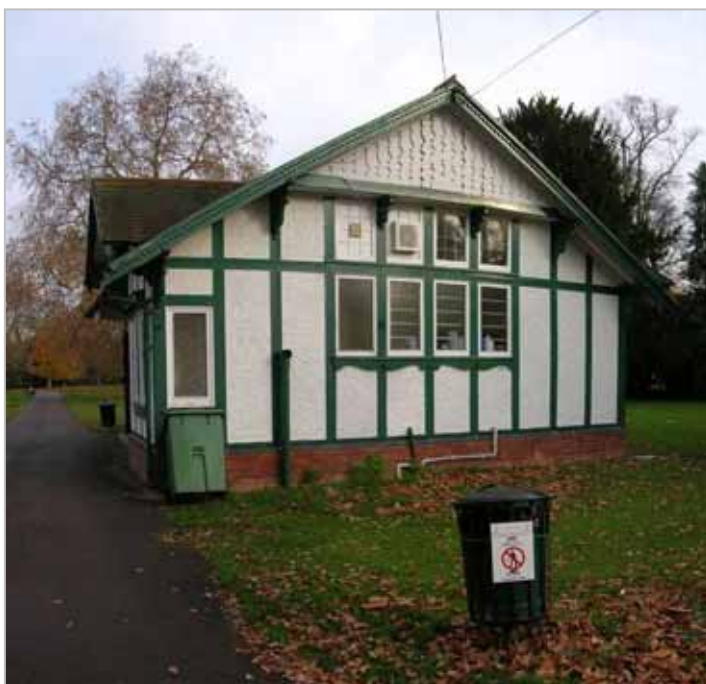
With the exception of the Scout Hut, all the buildings have a character which adds to the overall setting and have both a place in the history of the park and a current use today which secures their future.

2007 Central Cross Café (above) and Boat House (below)

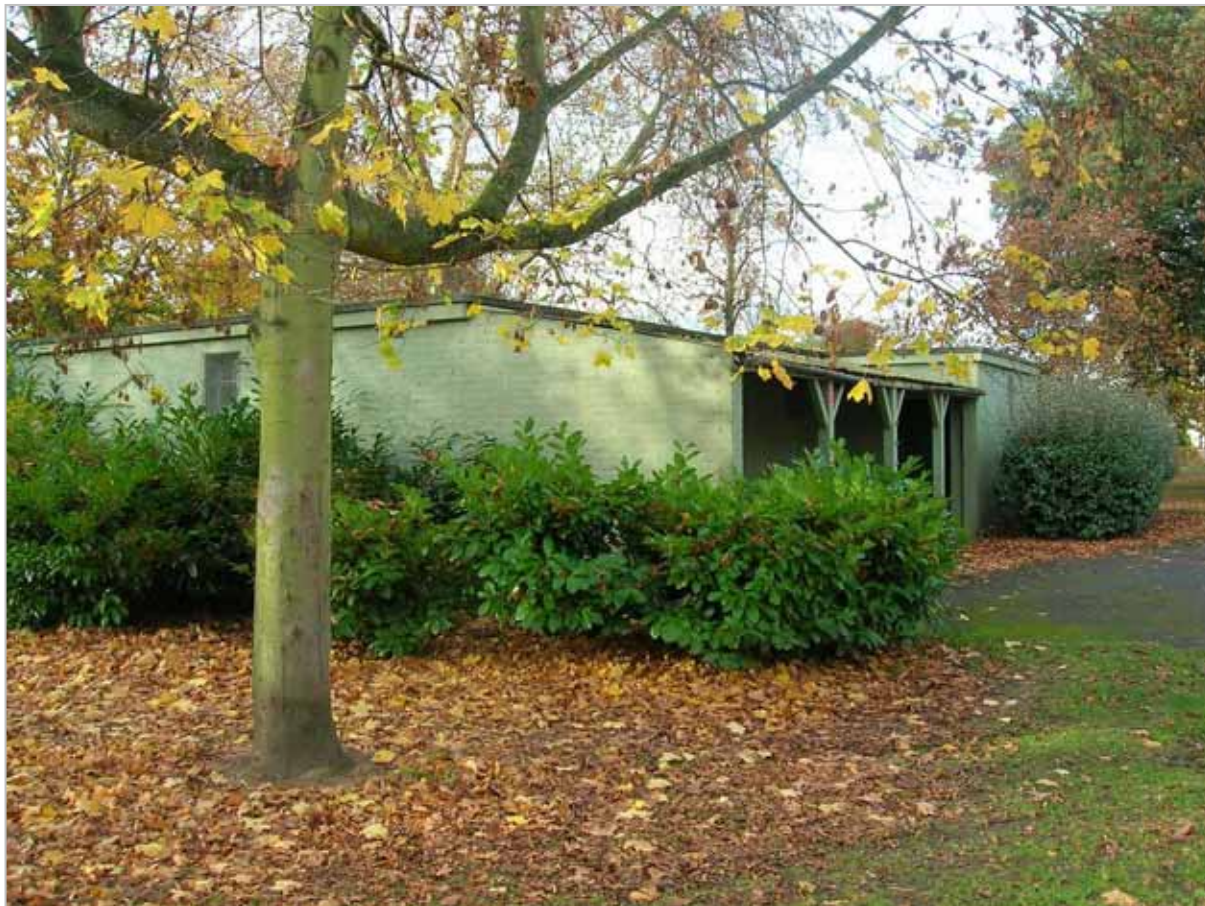
The Scout Hut dates from 1942 and is now considered to be one of the less attractive features within the park and which significantly blocks north-south views on the Pittville Lawns. Whilst this is a well used building, its structure and character detract from the historic setting of the park and whilst planting has to some extent been used to camouflage the structure, it is still a predominant feature on the Pittville Lawns.

2007 Scout Hut
