Swindon Village Conservation Area

Character Appraisal and Management Plan

Cheltenham Borough Council
Planning Policy Team
Local Plan Draft Document
May 2017

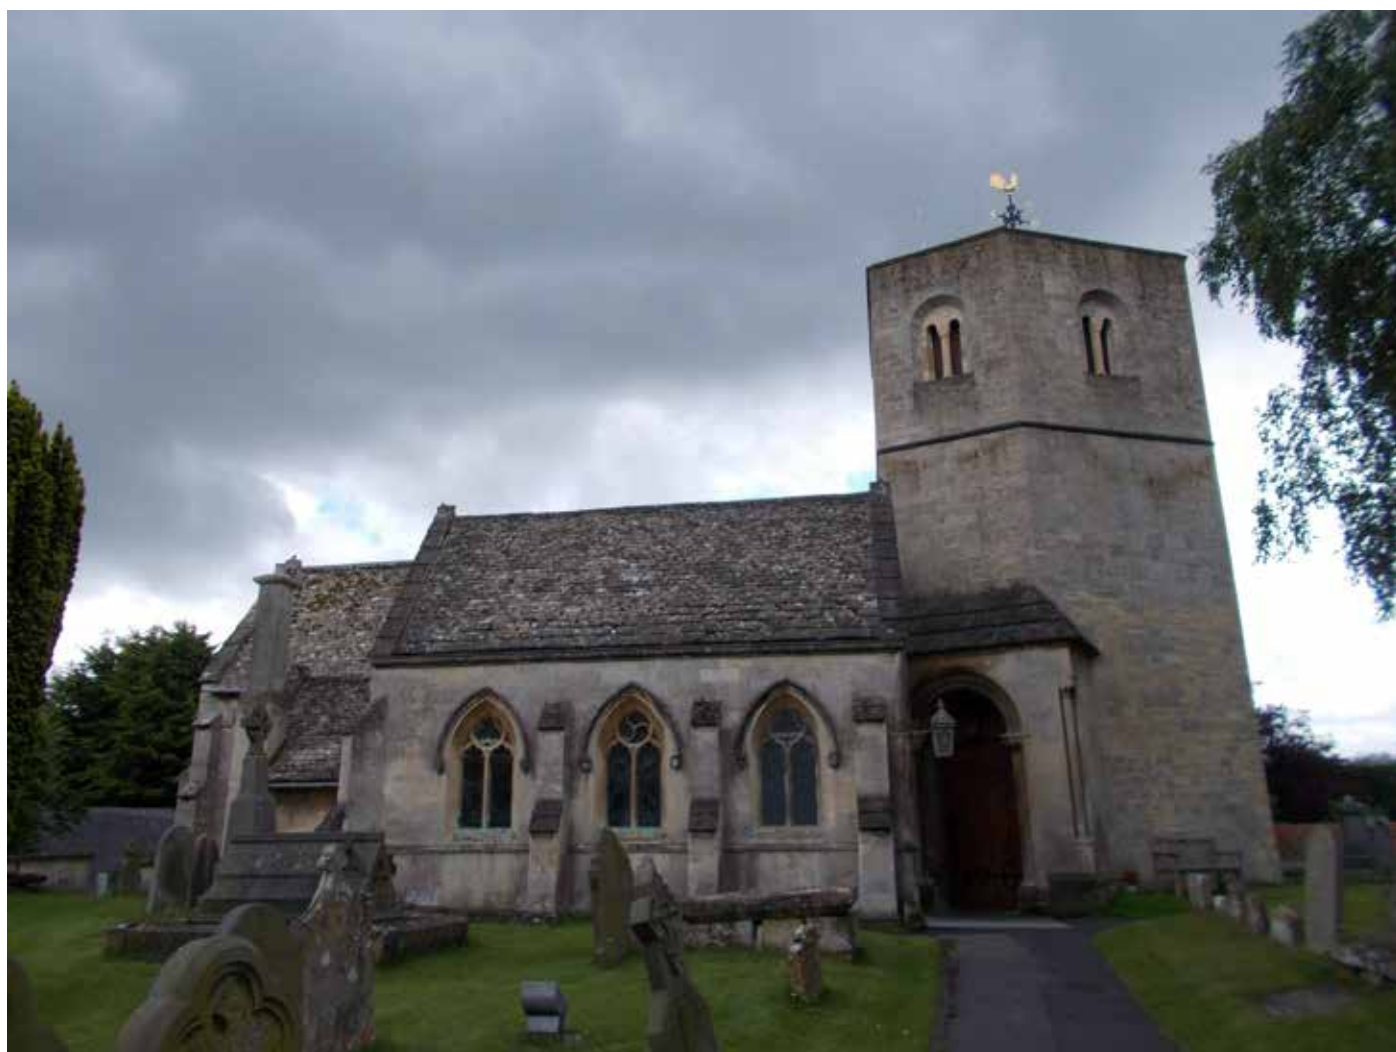
Fig.2.1 St Lawrence Church

2.2.2 The earliest surviving building is the tower of St Laurence's Church, dating from the early 12th century, and today Grade II* listed (Fig. 2.1). It is one of only two six-sided towers in the county.

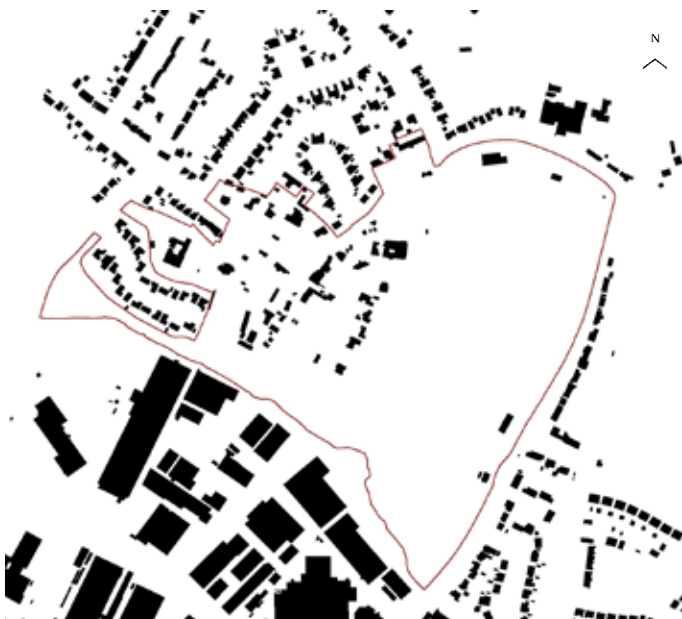
Map 7. Figure ground Plan of Swindon Village Conservation Area

conservation area are generally two storey. The massing is relatively consistent throughout, with large detached houses set within spacious gardens (MAP 7). Swindon Hall and Swindon Manor are notable for their larger massing, which can be accounted for the fact that these were higher status buildings originally set within expansive grounds.

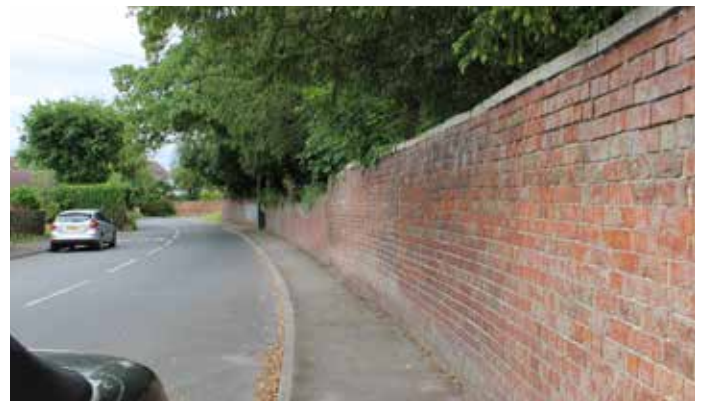
Fig.4.1. Historic Locally Listed boundary wall, Church Road

4.3.1 Traditional Historic boundary wall treatments of brick are common throughout the village of particular note, include two 19th century roughly 2m high locally listed brick walls running along Church Road (FIG.4.1). Other common boundary wall treatments include hedges along the edge of the playing fields and throughout the grounds of Swindon Hall and Lodge. Metal railings and associated gates also form a significant feature surrounding both Swindon Hall Lodge and St Lawrence Church.

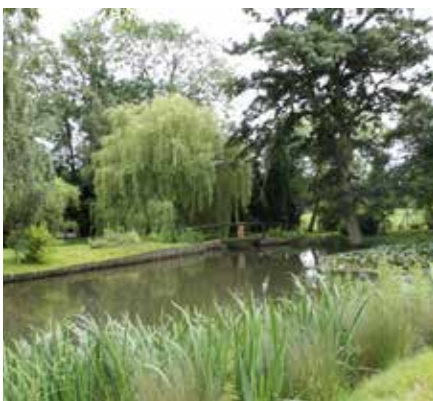
Fig.4.2 Moated site neighbouring Swindon Hall

The moated site behind Swindon Hall is an important historic element of the landscape that enhances the setting of the hall and the overall conservation area (Fig.4.4).

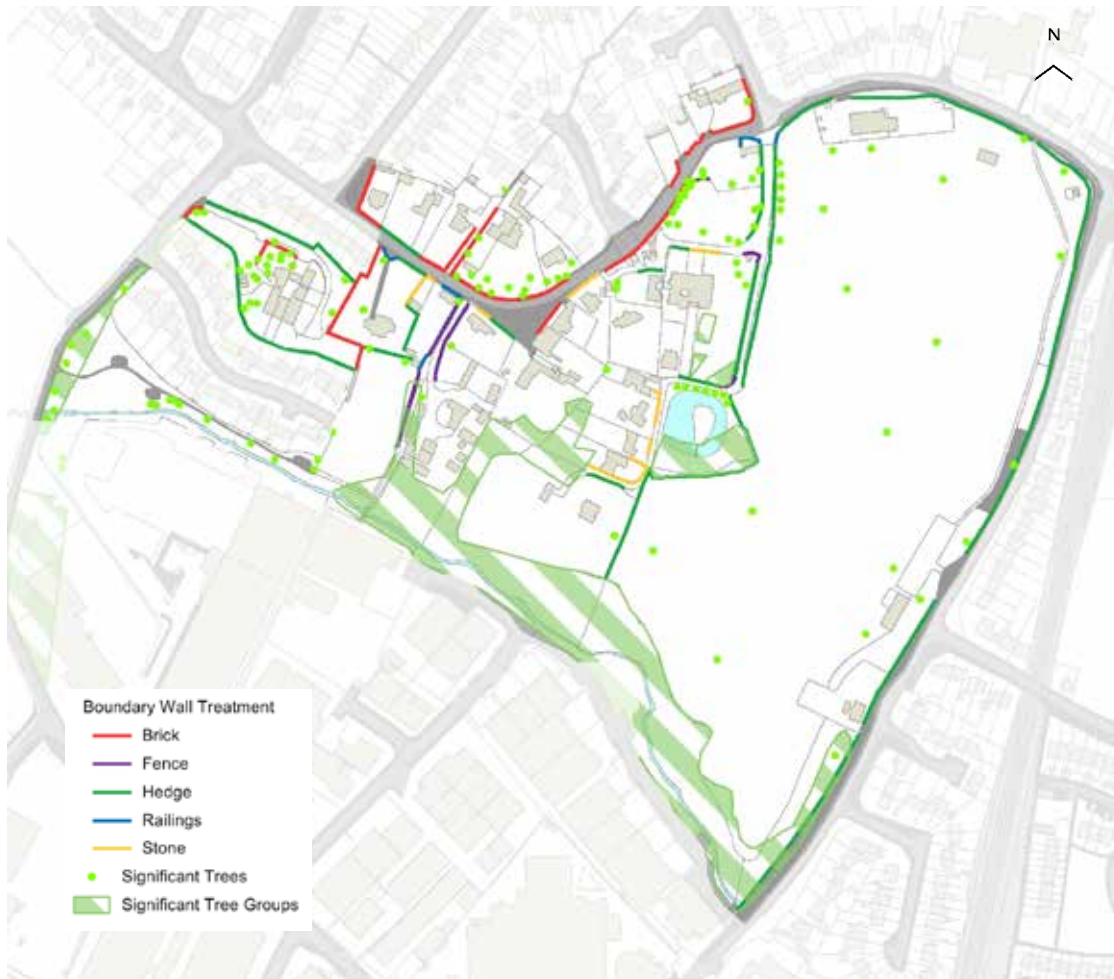
Map 9. Boundary Wall Treatments and Significant Tree Groups

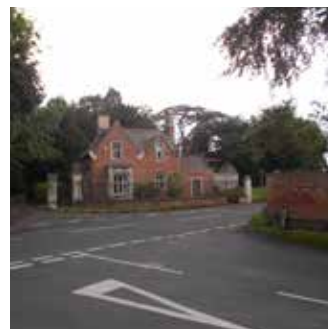
Fig.5.1 Larkfield, Wyman's Lane

5.3.3 On the west side of Wyman's Lane there has generally been little development with the notable exception being the locally listed Larkfield, a late 19th century red brick, two storey former gatehouse for Swindon Hall (Fig.5.1). The property marks the entrance of the original drive across the playing fields.

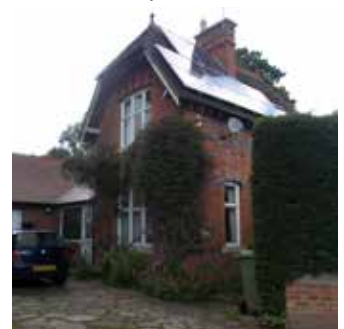
Fig.5.2 Swindon Hall Lodge

5.3.8 Swindon Hall Lodge a mid-nineteenth century grade II listed building, constructed of brick with ashlar dressing forms a prominent feature within the streetscape. (Fig.5.2) Attached to the east are two pairs of rusticated ashlar gate piers which flank an ornate pedestrian gate and the surviving entrance drive to Swindon Hall.

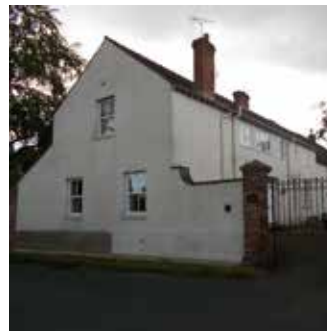
Fig.5.3 The Grange

5.3.7 The Grange, a two storey former stables and coach house for Swindon Hall has a visually prominent position in the centre of the village and marks entrance of the Conservation Area (Fig.5.2)

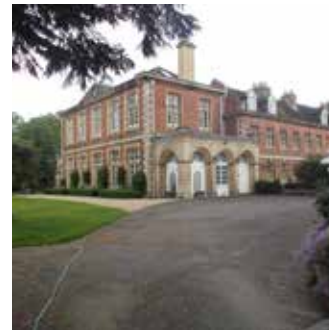
Fig.5.4 Swindon Hall

5.3.9 Swindon Hall accessed by a private drive is grade II listed and dating from the late 17th century although it was considerably remodeled in the mid 19th century in a domestic revival style (Fig.5.4). The interior largely reconstructed post world war two as a result of fire damage in 1949.

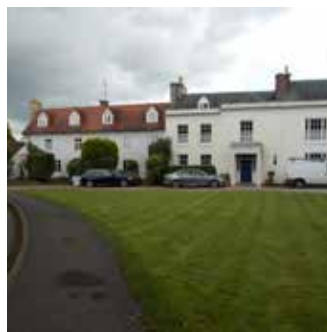
Fig.5.5 Old Swindon House & Queen Anne Cottage

5.3.11 Buildings on the Green make an important contribution when going through the village. This includes the late 18th century Old Swindon House and Queen Anne Cottage with its distinctive clay tile roof and gothic style glazing bars to the first floor (Fig.5.5).

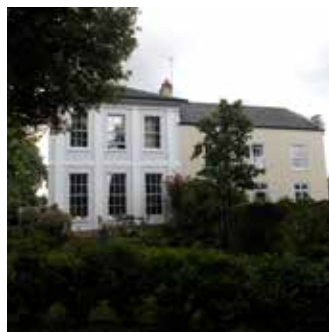
Fig.5.6 St Lawrence & The Old Rectory

5.3.13 The Old Rectory and St Lawrence, both grade II listed, early-mid nineteenth century rendered Regency villas (Fig.5.6). These are set back within mature gardens that make a distinctive contribution to the street scene.

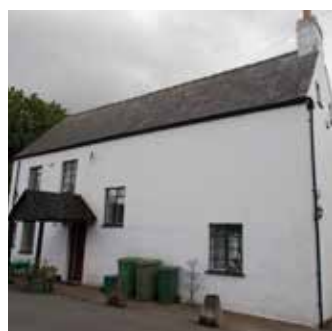
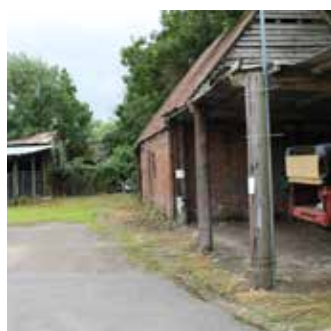
Fig.5.7 Swindon Manor Farm

Fig.5.8 Barns at Swindon Manor Farm

5.3.14 Swindon Manor Farm is set back from the road and comprises of a rendered 19th century farm house and an assortment of barns (Fig.5.7 & Fig.5.8). These are in a varied condition with a number in a semi-ruinous state. Nonetheless, this assortment of buildings demonstrate its historical development and rural character.

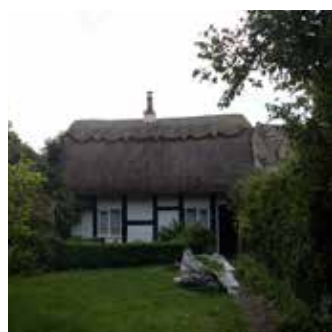
Fig.5.9 Church Cottage

5.3.15 Church Cottage, located adjacent to the church is a visually distinctive thatched and timber framed building dating from the 18th century (Fig.5.9).

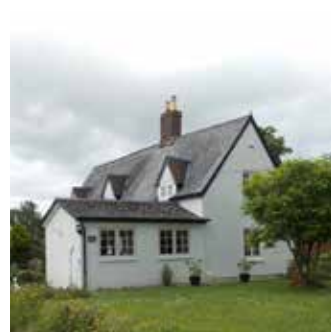
Fig.5.10 Laburnman House

5.3.17 Laburnam House while unlisted likely dates from the 17th century although has gone through numerous alterations and extensions (Fig.5.10). It is rendered with slate roofs and a good example of vernacular architecture.

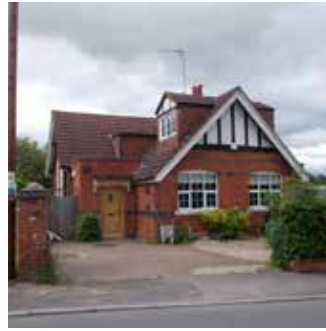
Fig.5.11 The Old School House

5.3.18 The Old School House was built in 1908, sitting in a prominent position as you enter the conservation area from the west (Fig.5.11). The building today has been unsympathetically converted into residential use.

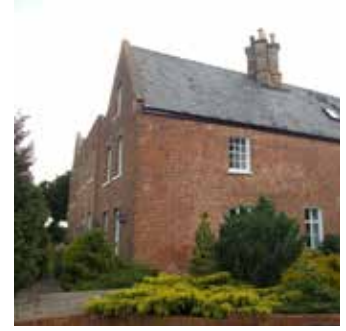
Fig.5.12 Swindon House

5.3.19 Swindon House, a large detached house dating from the 17th century, but largely rebuilt in the 18th subsequently extended and subdivided into separate dwellings in the 1990s (Fig.5.12) It is set within spacious grounds with mature trees overlooking St Lawrence's Church.

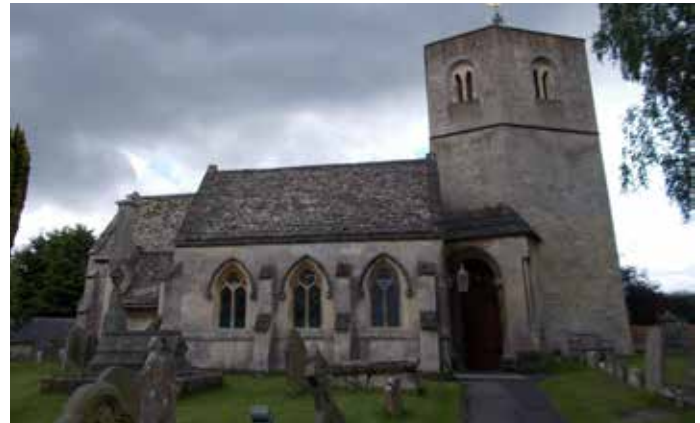
Fig.5.13 St Lawrence's Church

5.3.16 St Lawrence's Church is the only grade II* listed building in the village and is notable for its hexagonal shaped Norman tower (Fig.5.13). Dating from the 11th century, it was heavily altered in the 1840s.

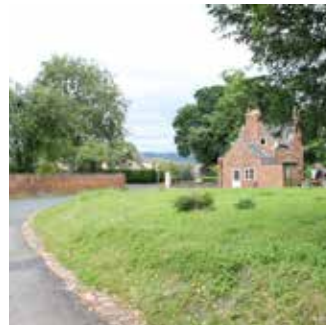
Fig.6.1 Loss of boundary wall

- Road traffic, particularly during school pick up and drop off (Fig.6.2)
- Poor quality surface materials
- Loss of boundary walls (Fig.6.1)
- New developmet affecting the setting of the conservation area

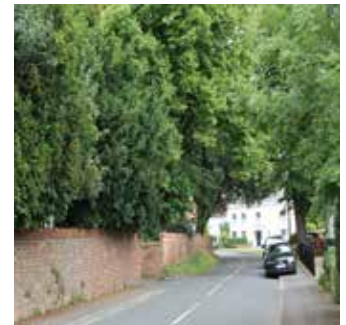
Fig.6.2 On street parking

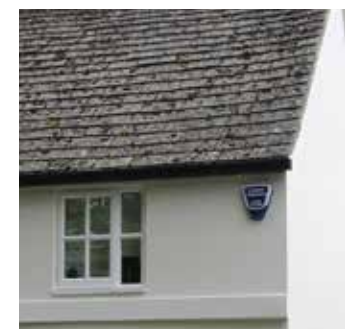
Fig.6.3 Introduction of alarm boxes

- New development of a poor quality design/materials or inappropriate siting, scale and massing
- Subdivision of plots
- Poor maintenance of buildings
- Loss of historic features
- Replacement of historic timber windows with uPVC
- Installation of alarm boxes and satellite dishes visible from the street (Fig.6.3)
